## Experimental study on corrosion of transmission line tower foundation and its rehabilitation

S.Christian Johnson<sup>1</sup> G.S.Thirugnanam<sup>2</sup>

In this paper, Physical, Chemical and electro chemical parameters, studied on transmission line tower stubs excavated from inland and coastal areas have been presented. A methodology for rehabilitation of transmission tower stubs has been discussed.

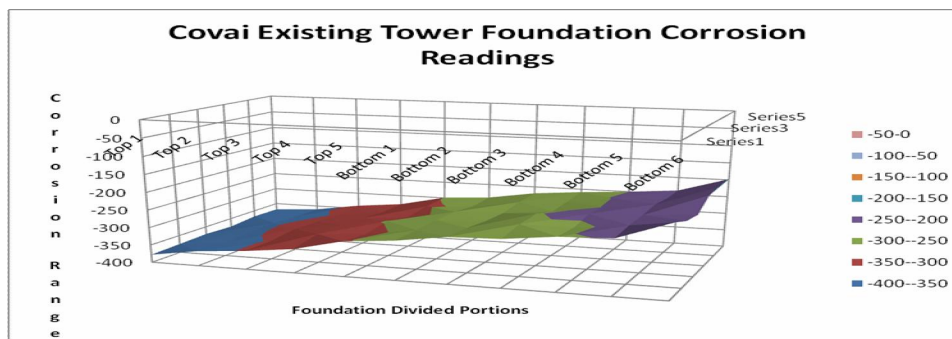
Fig.9. Equipotential map of the stub excavated in the inland area

Half cell potentiometer readings taken on stub 1 and stub 2 are furnished in the table 1& 2. and Fig. 9 & 10 shows the corresponding equipotential map

The embedded portion of the stubs in the inland area are almost unaffected by corrosion and the half cell potentiometer readings confirm this.

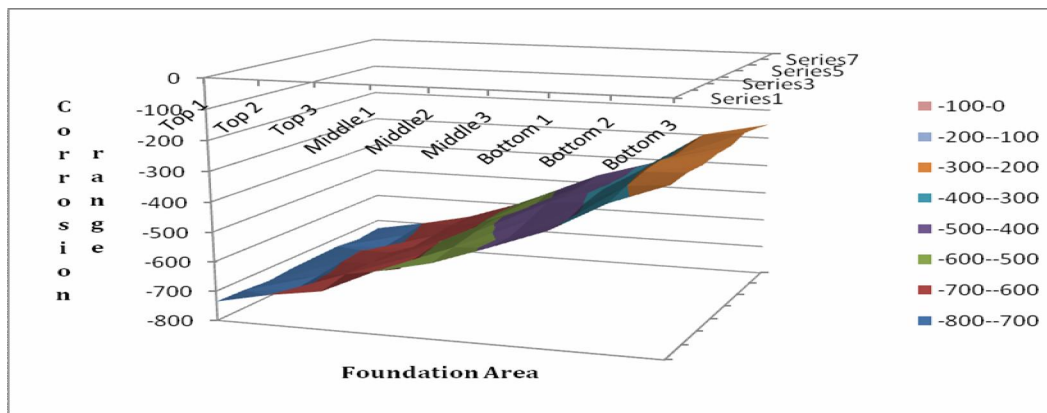
Fig.10 Equipotential map of the stub excavated in the coastal area

The stubs tested in the coastal areas shows all the readings above ASTM limit and the corrosion level is alarming also in the embedded portion.

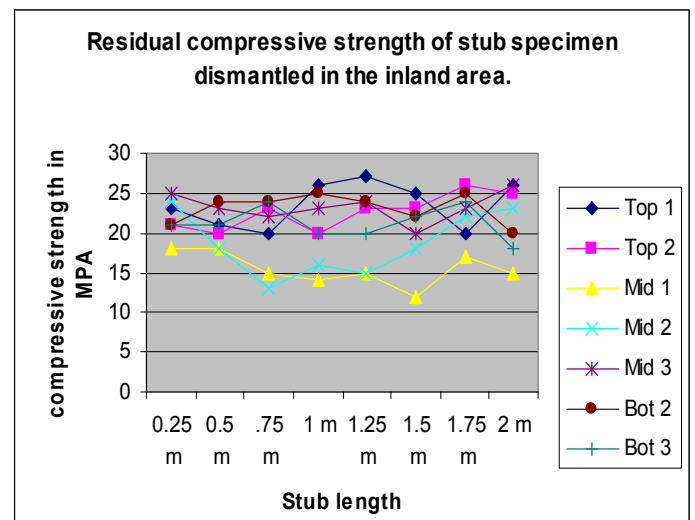
Fig.11.Variation of compressive strength along the length of the

The rebound hammer test conducted on the stub from inland area indicates the concrete strength above M 20 and this is due to the fact the concrete is not affected by carbonation or chloride ingress.

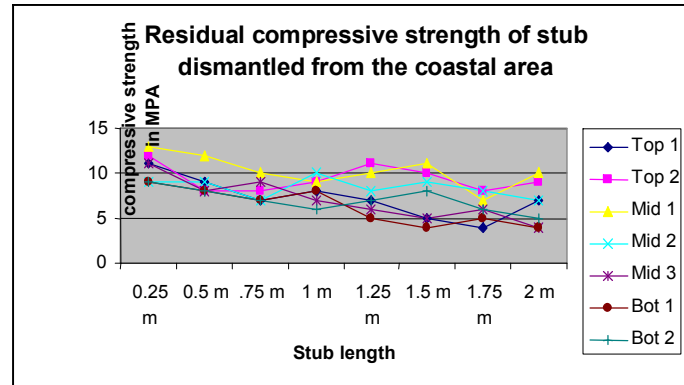
Fig.12. Variation of compressive strength along the length of the stub specimens

The rebound hammer test conducted on the stub from inland areas indicates lesser than M10 concrete in the major area of embedded portion of the stubs because of carbonation, chloride and other chemicals in such a coastal cum industrial environment.

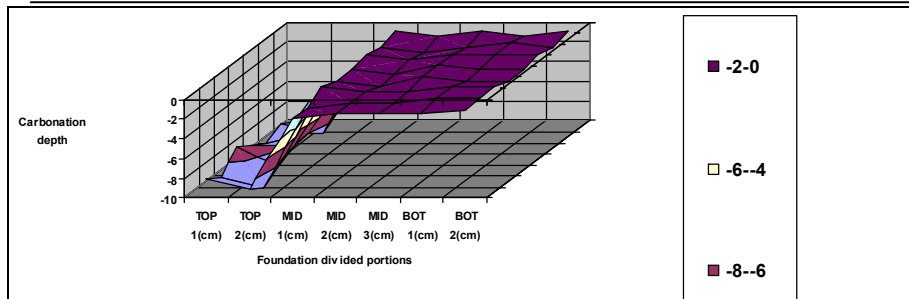
Fig.14 Carbonation depth in the stub specimen dismantled at inland area

In the Inland specimens, the full carbonation in the coping portion is due to failure of coping due to poor quality and bond.

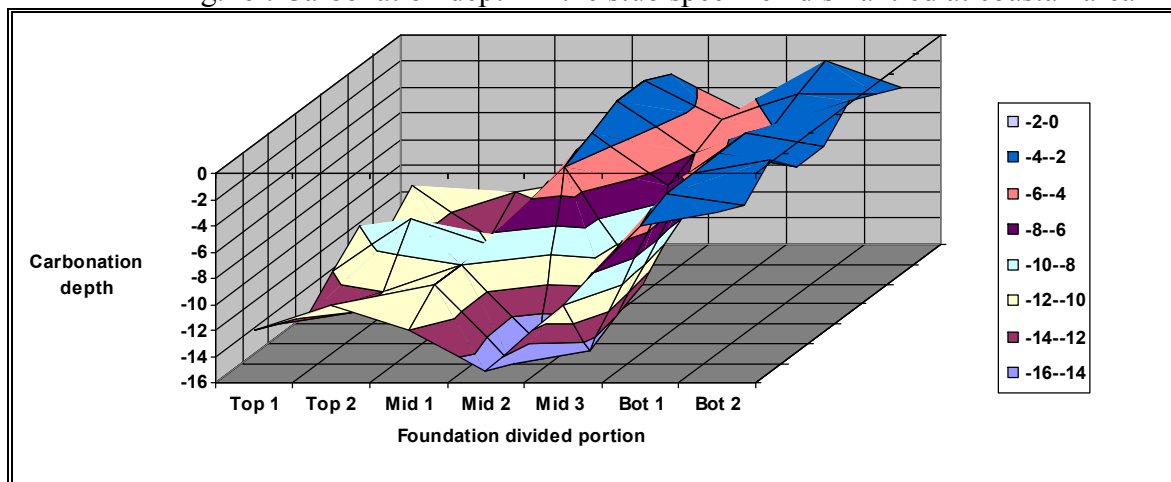
Fig.16 : Carbonation depth in the stub specimen dismantled at coastal area

The phenolphthalein test conducted shows clearly about the extent of carbonation depth. For about 35 cm from the Ground level, the total concrete has been carbonated in the coastal area.
