Performance Management of Transmission Line Tower Foundations against Corrosion by Non Destructive Testing

Abstract: In this paper, corrosion in overhead line foundations in different field environmental conditions (plain, agricultural and coastal/industrial region) have been detected by non-destructive test methods such as Half-cell potential test, Ultrasonic pulse velocity test, Rebound hammer test, chemical analysis of soil and Transmission Line Tower (TLT) footing concrete samples and scanning electron microscope (SEM) analysis of deteriorated tower footing concrete. The collected soil samples have been analyzed for chemicals and the TLT coping concrete samples have been tested using scanning electron microscope. The correlation between the test values, mineralogical composition of soil and concrete samples at tower footing level is presented.

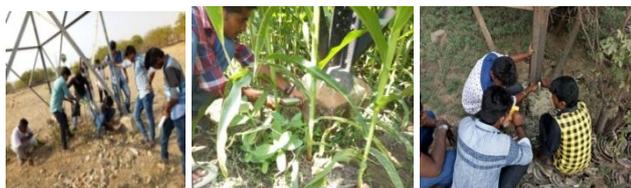
Fig. 1. NDT test in Plain, Agricultural and Coastal/Industrial Region

Six readings in each tower footings have been taken and average value has been recorded. The non destructive test values have been compared with the norms stipulated in the ASTM/IS Standards and the quality status of coping concrete is recorded in the Table VI. Fig. 1 depicts the conduction of NDT's in plain, agricultural and coastal/industrial regions.
