## **A Novel Protective Measure and Nano Penetrant Coatings against Corrosion of Power Transmission Line Tower Embedded Parts**

**Keywords:** Corrosion, Durability, Half-cell potential, Stub angle-coping concrete interface, Transmission line tower, Foundations, Nano penetrants, Woring.

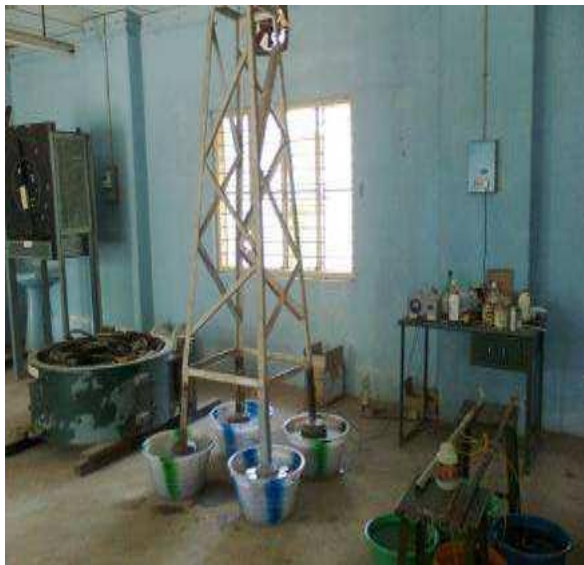
**Figure 1.** Model Tower foundation [Under corrosion acceleration]

In the experimental program, performance of experimentally proven coatings upon stub angle, admixtures in stub concrete and coatings on stub concrete surface i.e., three level protections and the formation of woring in the stub angle- coping concrete interface against crevice corrosion have been examined under accelerated corrosion upon a model tower. For this purpose, a model tower was fabricated using the angles of size 45 mm x 45 mm x 6 mm and the test set up is shown in figure 1.

A schematic view of acceleration set up is shown in figure1. Fly ash has been added in concrete as 20 % cement requirement in all the legs except the controlled specimen. FACSR coating has been applied over the stub angle as well as on the stub concrete. Demech

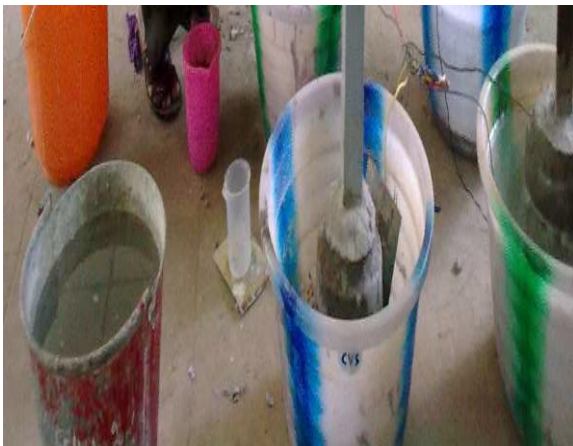
**Figure 2.** Close up view of leg of model tower [Casting of concrete around the stub angle and working in the crevice]

Different coatings were applied on different leg angles and admixture concrete designed for M 20 grade was cast around its four leg angles as coping concrete. After setting, the best protective coatings found through laboratory test results, were applied over the coping concrete surface. Besides, the protective coatings on stub angle and concrete surface, a deep pour grout out of a three part product polymer based material have been poured in the crevice of stub angle and concrete as a woring and observation was made under accelerated corrosion. The whole tower was lifted and placed upon 4 tubs filled with 3.5% Sodium chloride water electrolyte, so that each leg is in separate tub as shown in the set up shown in figure 2. The tower legs immersed in sodium chloride water electrolyte was subjected to accelerated corrosion.

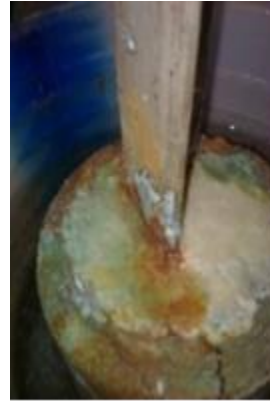
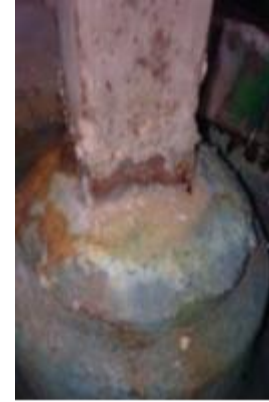
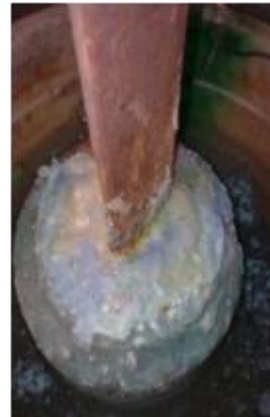
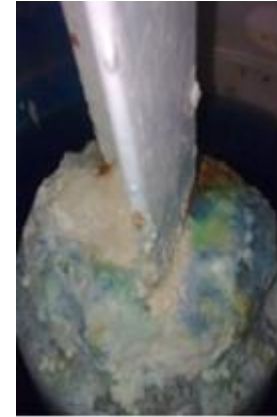
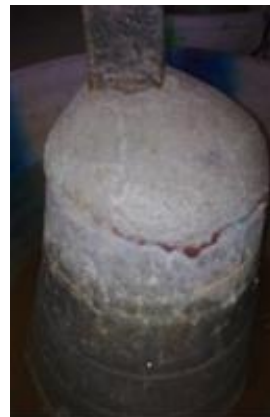
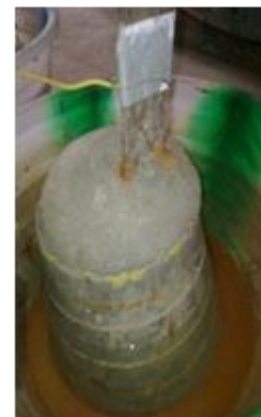
**Fig.3.** Deep pour grout workings after 500 hrs. of accelerated corrosion

chemical also has been applied over the stub angle and on the concrete surface. As for Nano Penetrant coating is concerned, the penetrant called Nano Zycosil, which has been used in this study is to be applied only on the concrete surface. A small zinc sheet has been wrapped on the stub angle very close to leg as a sacrificial anode in one of the leg members. After one test was over, the tower was lifted out of tubs, legs were replaced with new foundations with different coatings and test was repeated three times. The average Half – Cell potential values taken on the tower foundations of model tower are shown in table 1. The close up view of working upon model tower foundation after corrosion acceleration is shown in figure 3. Observations made on working are recorded in the table 2.

From the Half-Cell readings, the corrosion initiation time required for controlled specimen was nearly about 200 hours. After 200 hours, the corrosion mechanism propagates rapidly. The effect of working at the crevice of concrete and stub angle of the model tower after 500 hours of accelerated corrosion is shown in the Fig. 3. The inclusion of corrosion Inhibitor delays the initiation period considerably by up to 400 hours, which is nearly twice that of controlled concrete. The results clearly indicated that the corrosion mechanism was not initiated even up to 500 hours in the nano penetrant coated specimens and sacrificial anode fixed specimens.

On comparing the test results, it is seen that the three level coated legs (FACSR coated angle + Silpas super and fly ash mixed concrete + externally coated by FACSR) exhibits good performance. Three level coatings (Demech chemical coated angle + Silplas super and fly ash mixed concrete + externally coated by Demech chemical) show a superior corrosion resistance. Transmission line tower leg coated with Nano penetrant does not show any corrosion symptoms even after 500 hours of accelerated corrosion. Stub specimens fixed with sacrificial anode show a very good resistance to corrosion. Deep pour grouting out of Demech chemical for providing working like part in the stub angle-coping concrete interface shows no symptom of rust till 400 hours of accelerated corrosion in the three level

protected legs. Where as in the single level protected and controlled specimen legs, many rust spots after 300 hours and rust staining after 400 hours of accelerated corrosion have been noticed. Hence, introduction of working in combination with three level protections will definitely enhance durability of tower foundations. This methodology of pouring deep grout for protecting the stub angle-coping concrete interface against crevice corrosion may be encouraged during the construction of transmission line tower foundations.
