New approaches for enhancing durability of transmission line tower foundations

S.Christian Johnson*, G.S.Thirugnanam , A.R.Santhakumar

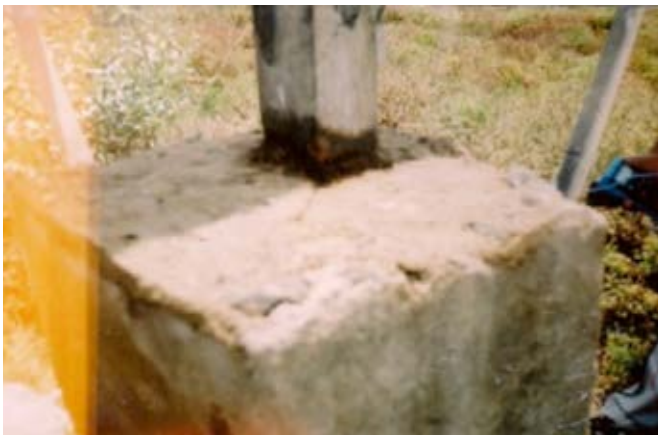
Fig.1. Formation of pitting corrosion at the angle concrete interface

level called coping concrete should have a muffing portion in slanting way. But in some cases it is observed that this is missing resulting in stagnation of water leading to pitting corrosion as in Fig.1. Ingress of saline water or other pollutants etc., leads to the formation of local cracks and chip off, which allows salt to penetrate further into the affected stub where the process of corrosion will be more and more accelerated as in Figs. 2 and 3 resulting in bulging and snapping of angles.

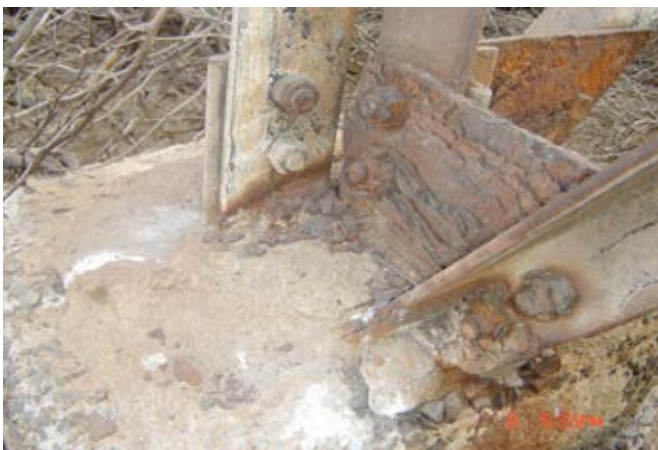
Fig.2. Bulging of stub angle

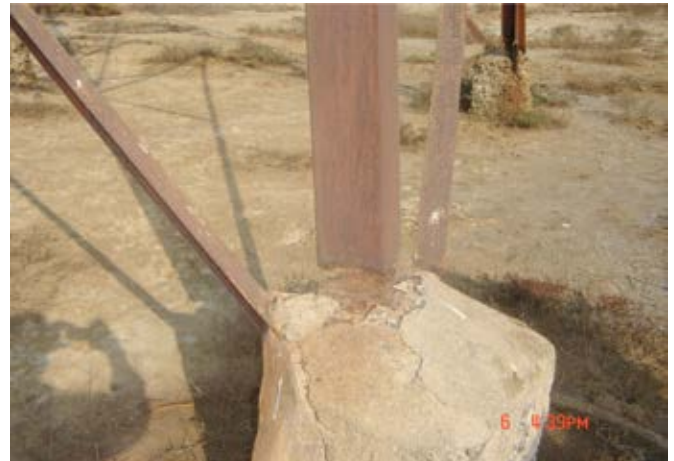
Fig.3. Snapping of stub angle

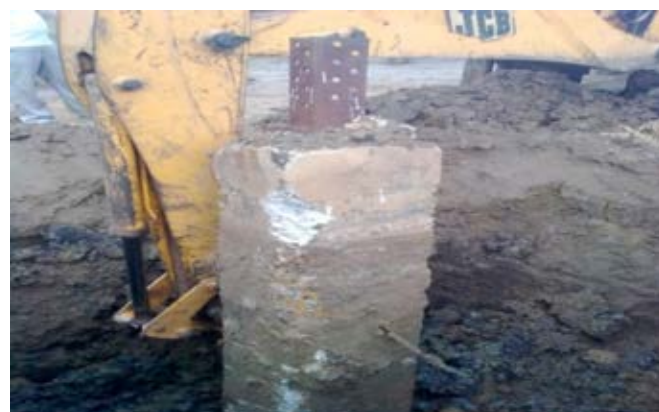
Fig.5. Removal of coastal stub

As a part of the study, TLT stubs in two strategic locations had been removed by excavation after obtaining permission from the TNEB authorities for diagnosing purpose. The tower stubs as shown in Figs.4 and 5 were cut removed and transported to the lab at Hydro Training Institute, Kuthiraikalmedu, Tamilnadu, South India for testing purposes. The stub of these towers was erected nearly 30 years ago, and the super structures had been already dismantled for expansion purposes. To assess the condition of those stubs several tests/studies have been carried out as below.

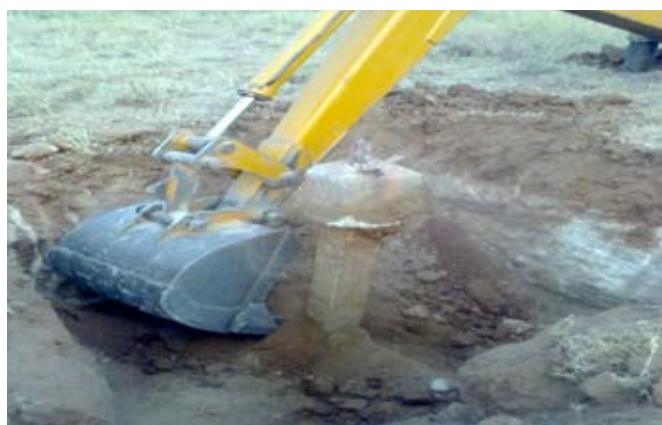
Fig.4. Removal of inland stub

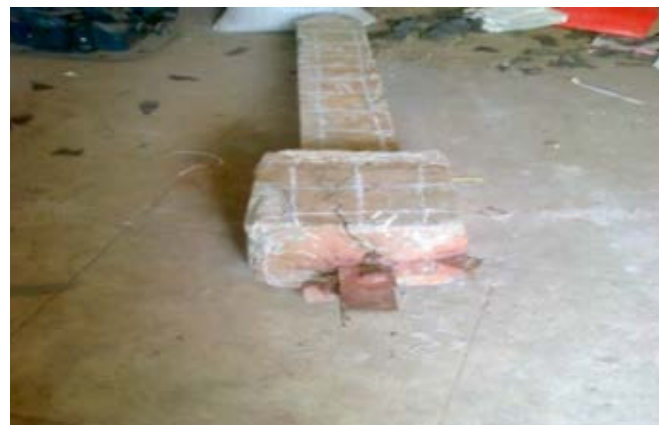
Fig.6. Close up view of Inland specimen

Half-cell potential test has been conducted on each side of the stub over the grid lines drawn on the inland stub as shown in fig.6. Though all the Half-cell potential values are negative, throughout the paper they have been shown as positive for drawing graphs.

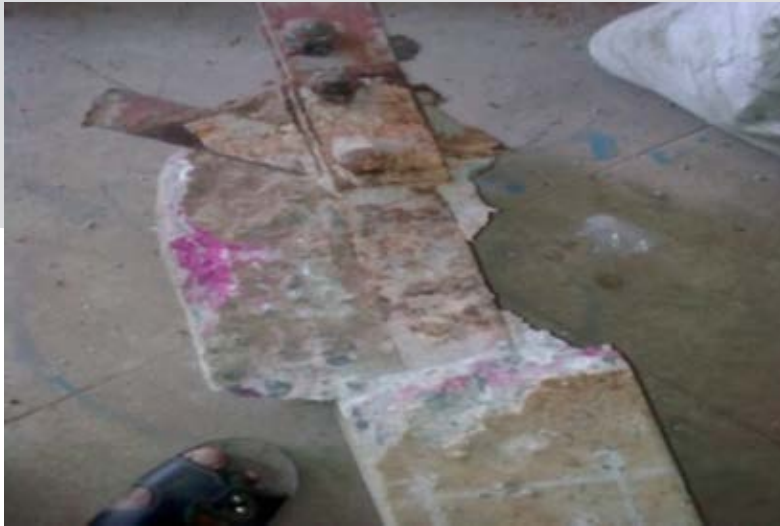
Fig.7. Close up view of inland stub specimen on removal of stub concrete

and compared with the original thickness. The close up view of inland specimen at the broken stage during carbonations test is shown in Fig.7 and the Fig.8 shows the coastal specimen while the stub concrete was removed during the carbonation test.

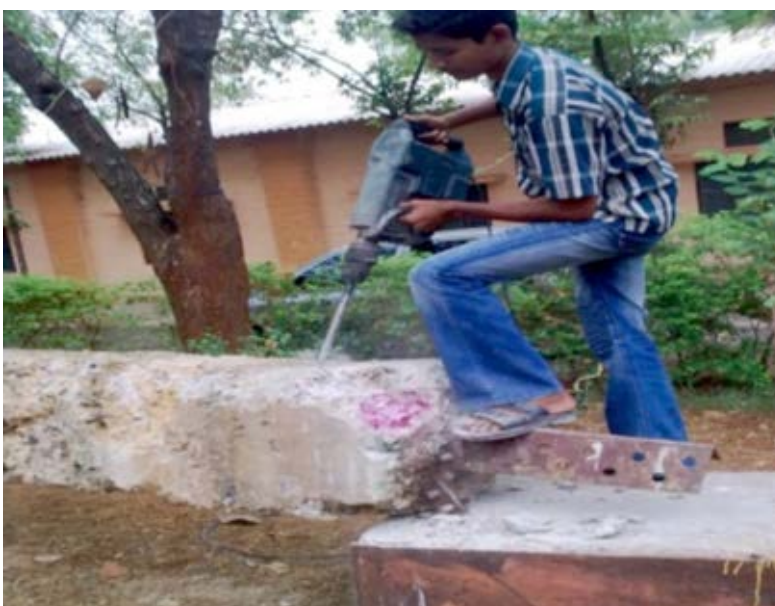
Fig.8. Close up view of coastal specimen on removal of stub concrete

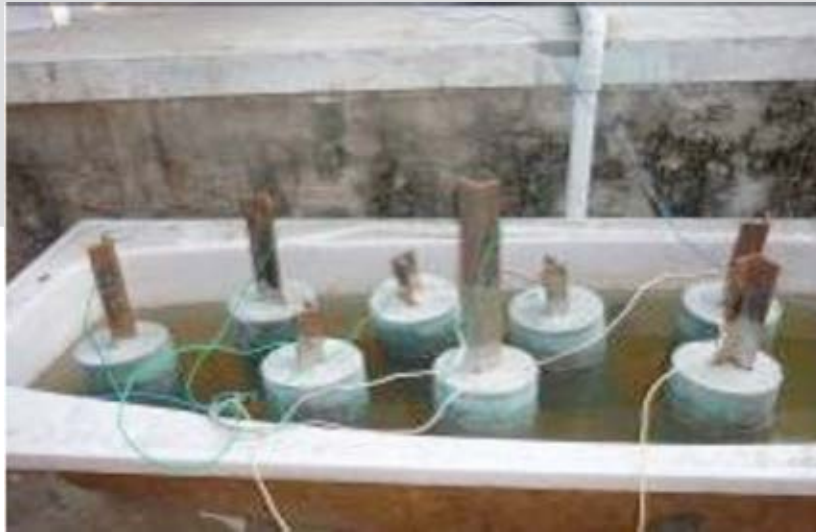
Fig.9. Acceleration corrosion test set up

In the accelerated corrosion test, the specimens were centrally placed in the container surrounded by stainless steel plate, which act as cathode and the container was filled with 3% NaCl electrolyte. The concrete cylindrical specimen of size 1500 mm x 300 mm were embedded with 50 mm x 50 mm x 6 mm angle as a stub. To assess the corrosion resistance efficacy of the different level of

In the experimentations, a constant potential of 12 V was applied to this system using a DC power supply regulator. The variation in the development of current was monitored at regular intervals using a high impedance multimeter, as per ASTM C876-90 and the acceleration corrosion test set up is shown in fig.9. The Half-cell Potential values were measured on those specimens at specific intervals of time. As the average chloride

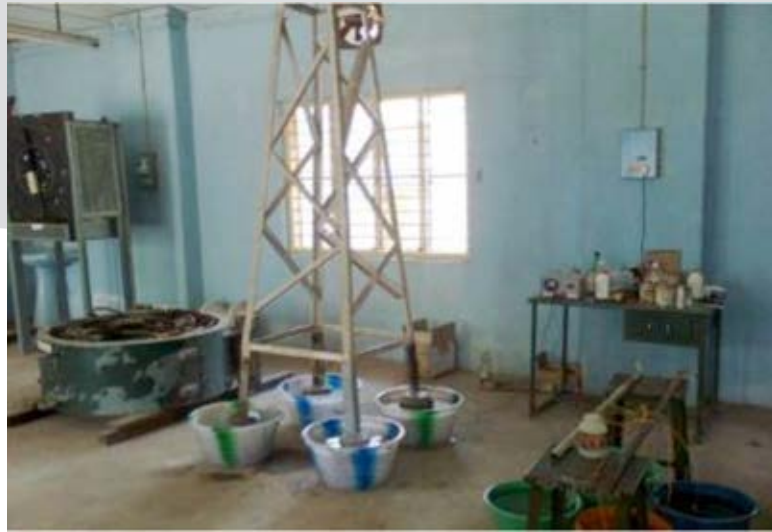
Fig.10.Model tower combined with foundation concrete- stub system

A model tower was fabricated for testing combined foundation concrete- stub system. The concrete mix was M20 as in the field was followed for the model tower foundations. The tower angle was black steel angle. In this model tower, the best protective coatings found through laboratory test results, were applied over the leg members. Besides the above, sacrificial anode was introduced separately in one of the leg member. In order to evaluate the performance of O-ring against corrosion in the stub angle concrete interface, Demech deep pour grout was poured in the interface of stub angle and concrete to form O-ring. The whole tower was lifted up after the foundation was cast and curing was over and the tower was placed upon four separate plastic containers so that each leg was positioned in a plastic container. The acceleration corrosion test was conducted similar to laboratory specimens. In the first test up, the tower foundations have been referred as controlled specimen MTF1 (Model tower foundation 1), Corrosion inhibitor added specimen MTF2, Flexi bond ACSR coated stub angle and concrete surface with SP concrete MTF3, and Demech Coated stub angle Nano penetrant, FACSR and Demech coated stub angle and concrete surface with SP concrete MTF4 have been tested. In the second test set up MTF1 and MTF2 was repeated in two of the legs along with one cement slurry coated stub angle and Nano Zycosil coated concrete surface over the SP concrete tower foundation, MTF5 and the sacrificial anode wrapped stub angle above the SP concrete tower foundation concrete, MTF6. The Half-cell potential readings taken at specific intervals of time and observations made on the O-ring formed using Demech deep pour grout are shown in Table.5. The close up view of the model tower with combined foundation concrete- stub system for acceleration corrosion test is shown in Fig. 10.

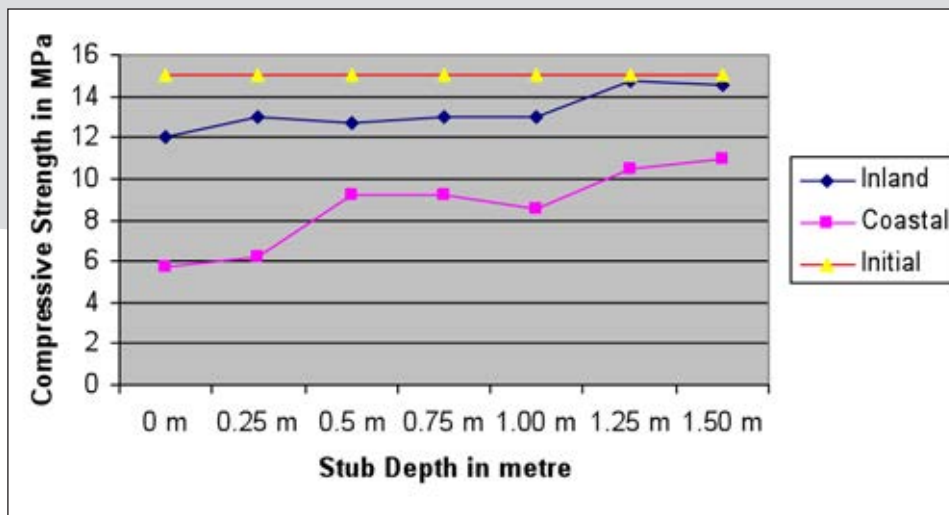
Fig. 12. Comparison of inland and coastal stub with respect to compressive strength

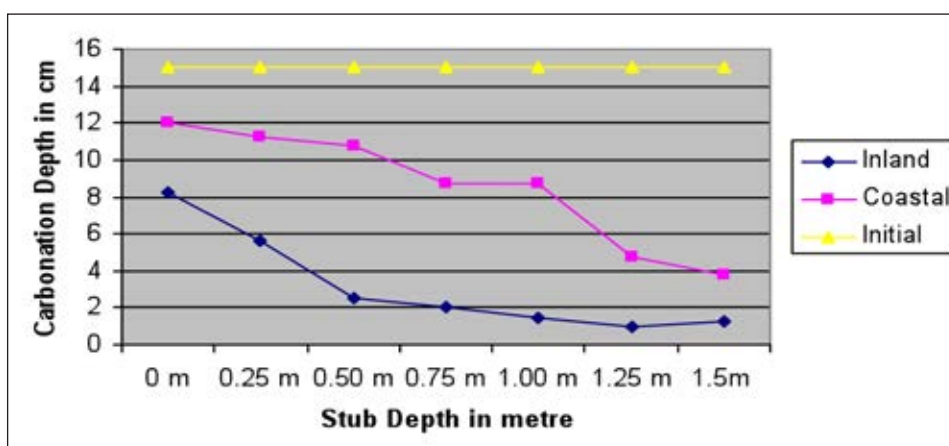
Fig.13 Comparison of inland and coastal stub with respect to carbonation depth.

From the results of carbonation test, it is observed that the top portion of the stub concrete (350 mm from ground level) has been affected by carbonation. In the Inland specimens, the full carbonation in the coping portion is due to failure of bond and poor quality. Fig.13 shows the variation of carbonation depth with respect to depth of the stub.

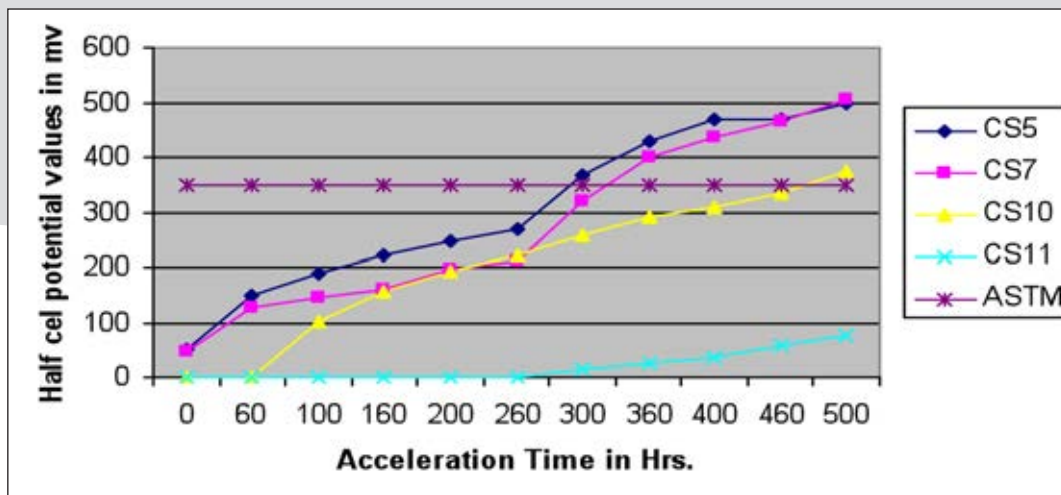
Fig. 14 Comparison of best 3 level protection specimen in accelerated corrosion test

It was noted that, the FACSR specimens (3 and 2 level protections (CS5 and CS7), Demech coated specimens (3 level protection (CS 10)) performs well when compared to other specimens in accelerated corrosion tests. This is due to higher resistance of these coatings materials against chloride ingress. The longer initiation period of FACSR coating and Demech coating is due to the Barrier nature of the coatings. Nano penetrant applied specimen (CS11) shows a superior performance over FACSR and Demech coated specimens. The comparison of these best 3 level protections is shown in Fig 14. Fig.15. shows the variation of current density value with respect to acceleration time for the best three level protections.

It can be seen that for all coated angle specimens, the time required for cracking is higher compared to uncoated specimen. For FACSR coating and Demech coating, the behavior of current density exhibited that there is an initiation period followed by propagation period. This observation is due to a higher resistance of these coating materials against chloride ingress. The longer initiation period of Demech, FACSR and Nano Zycosil coating is due to the barrier nature of the coating.

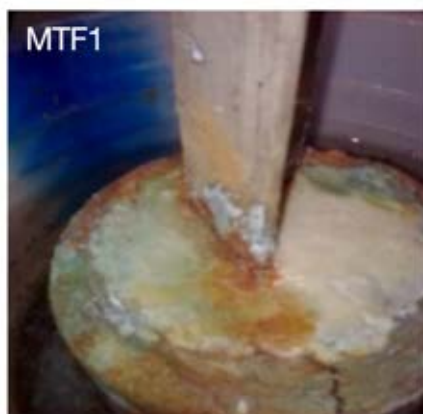
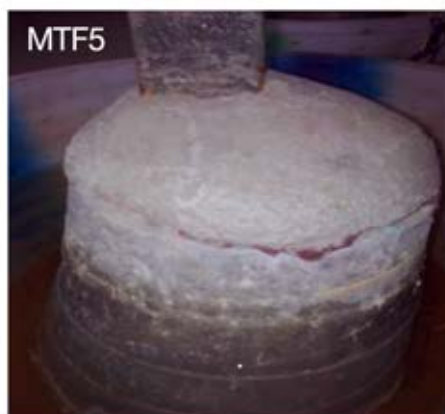
Fig.17. Deep pour grout o-rings after 500 hrs. of accelerated corrosion

Nano penetrant, FACSR and Demech coated specimen and sacrificial anode specimens perform very well in both accelerated corrosion test and impressed voltage test. Deep grouting out of Demech chemical for forming O-ring in the stub angle and concrete interface shows no symptom of rust staining till 400 hrs of accelerated corrosion. At 500 hrs few rust spots has been noticed. The effect of O-ring against crevice corrosion is very good for nano penetrant coated specimen. The observations made upon the O-rings are presented in Table 6. The close up view of O-ring formed in controlled specimen (MTF1), Nano Zycosil coated (MTF5) and Sacrificial anode fixed (MTF6) are shown in fig.17

penetrant are functioning far better while applying them over the rehabilitated concrete surface. Provision of O-ring in the stub angle and concrete crevice by Demech deep pour grout eliminates development of crevice corrosion. Hence cementitious replacement of ordinary replacement by 20% of fly ash and coatings like FACSR or Demech chemical or Nano Zycosil preferably on the concrete surface besides inclusion of O-ring by the polymer material like Demech deep pour grout are utmost essential for making the transmission foundation a durable one.
