Quasi- static indentation properties of damaged glass/epoxy composite laminates repaired by the application of intra-ply hybrid patches

J. Jefferson Andrew, V. Arumugam, C. Ramesh, S. Poorani, C. Santulli

To appear in: *Polymer Testing*

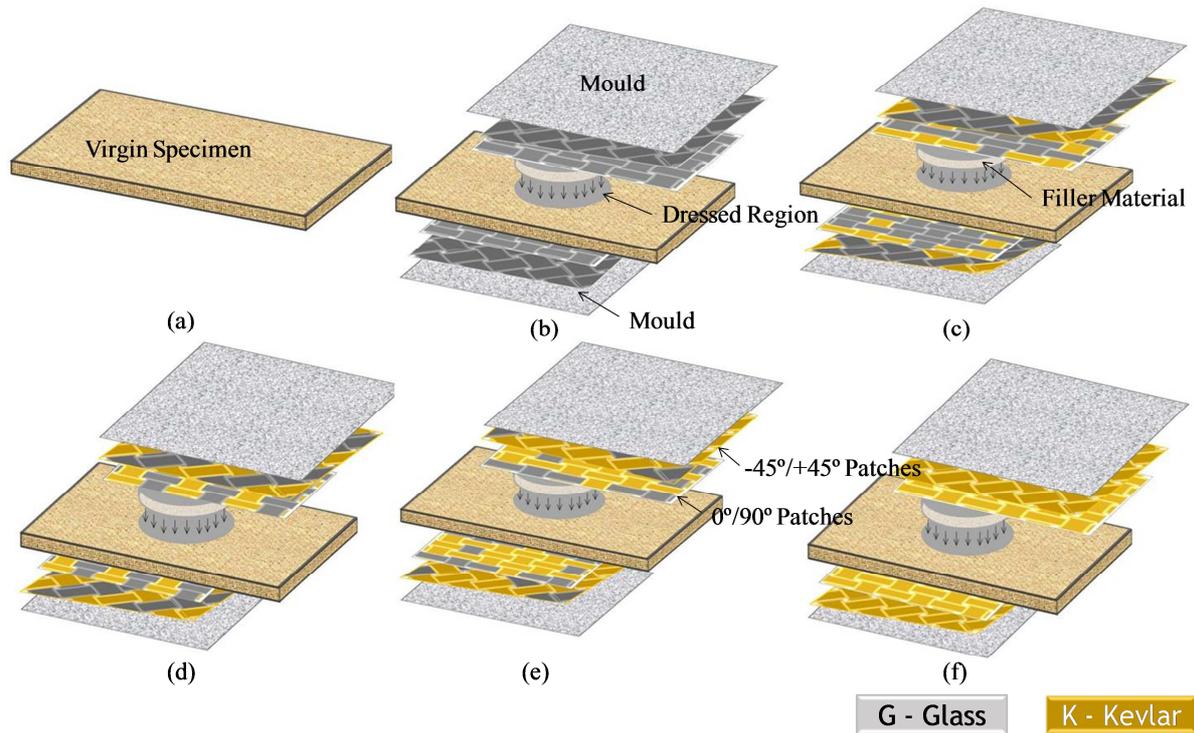
Figure 1 The structure of composite specimens considered in this study: (a) Virgin glass/epoxy specimen, dressed specimens repaired using (b) 100G patches, (c) 75G25K patches, (d) 50G50K patches, (e) 25G75K patches, (f) 100K patches

After fabrication, 20 of the 24 specimens were prepared for repair operation. Since external patch repair technique was employed in this study, a through hole of diameter 20 mm was produced in the geometric center of the specimens using an abrasive water-jet cutting machine to induce damage. Moreover, this kind of removal comes about in low velocity impact damage [9]. Before starting with the repair process, the damaged area of the glass/epoxy specimens was wiped using acetone solution to avoid the presence of contaminants and debris from cutting operation (as per standard ASTM D2093) after the water-jet machining process. An epoxy adhesive reinforced with chopped fibers (in a ratio 1:1 by weight) was selected to fill the dressed region, as they showed superior mechanical response to transverse loading [26]. During the repair process, the surplus resin spread around the repair site over the parent laminate was cleaned using cotton immersed in an acetone solution. Bidirectional plain weave square patches with sides of length 60 mm were then externally bonded over the surface of the damaged region of the glass/epoxy specimen. The fiber architecture and the thickness of the individual patches were identical to that of the fabric used to fabricate the parent laminate. Yarn type glass and Kevlar fibers were employed to fabricate intra-ply hybrid patches. Table 1 summarizes

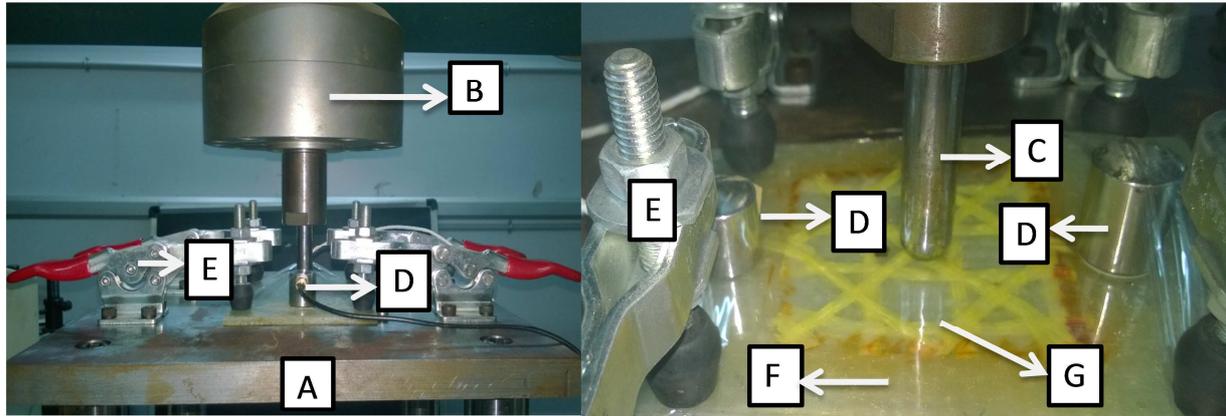
A - ASTM D6264-98 Indentation Fixture **B** – 100 kN Load Cell **C** – Indenter **D** – AE Sensor,
E - Toggle Clamps **F** - GFRP Repaired Specimen **G** – Repaired Area

Figure 2: Glass/epoxy repaired specimen clamped in ASTM D 6264-98 indentation fixture.

Cyclic quasi static indentation tests were performed in a Tinus Olsen Universal Testing Machine (UTM), equipped with a load cell of maximum load capacity 100 kN, at 0.5 mm/min. Incremental displacement steps of 2, 4, 6, 8, 10 and 12 mm were applied one after the other from the point where the indenter initially contacted (i.e. during 1st indentation cycle) the specimen's surface (including the dent depth). Tests were conducted on both virgin and repair specimens according to the standard ASTM D6264-98. The virgin specimens were used as a reference for comparing the residual strength and mechanical behavior of different repaired specimens. A total of four specimens were tested in each category and the averages of results were considered for interpretation. The rectangular specimens to be tested were firmly fixed on the indentation fixture using toggle clamps (see Figure 2). A hemispherical-faced indenter of diameter 12.7 mm was used to perform cyclic indentation directly above the geometrical center of the repaired region. A Physical Acoustics Corporation (PAC) Acoustic Emission (AE) monitoring device was employed to monitor the real-time dynamic changes within the repaired composite laminates during each cycle of the indentation events. Two wide-band differential AE sensors of operating frequency range 100-900 kHz were used to acquire the stress wave signals generated during fracturing of the repaired specimens under mechanical loading. The distance between the repaired region and either of the two AE transducers was 50 mm. High sealant vacuum grease (silicon grease) was used as the coupling agent between the AE sensor and the repaired glass/epoxy specimens to improve acoustic coupling between them. The AE device was equipped with an eight channel PCI-8 board with a sampling frequency of 4 MHz to simultaneously perform operations such as AE signal acquisition, AE signal processing and high speed transfer of AE data. The acoustic activities and signal parameters were monitored in real-time using AE Win software supplied by PAC. In order to boost the strength of weak acoustic signals for further processing and to reduce the consequence of interference due to external sources, the pre-amplifier gain was set to 40 dB. The amplitude threshold was fixed to 40 dB, which prevents acquisition of unwanted ambient noise signals during damage monitoring process. The wave velocities were mean values estimated as per the standard ASTM E976-10 pencil break test method. The average wave velocity was found to be 3146.3 m/s. The AE events that were recorded by both the sensors were utilized for the data processing.

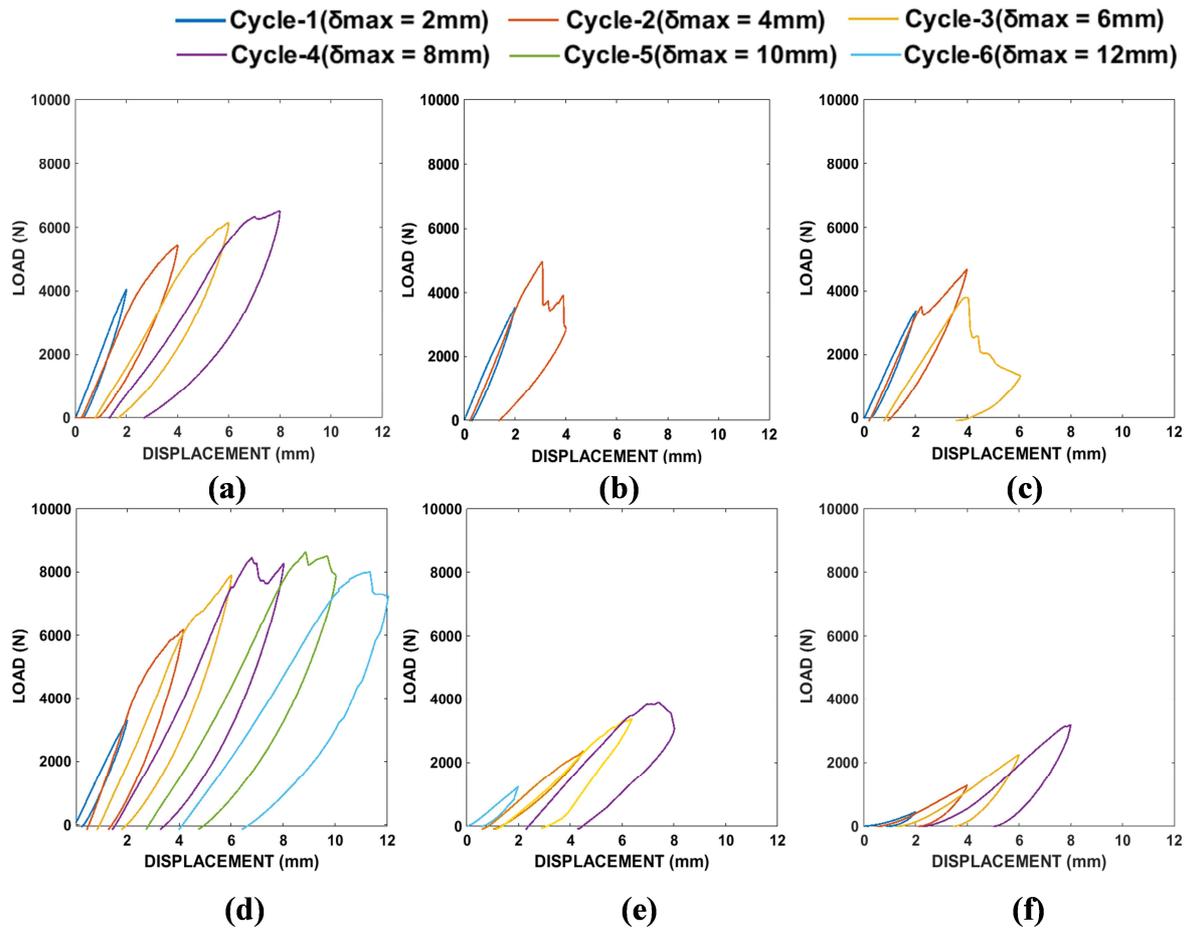
Figure 3: Force-displacement curves for (a) Virgin glass/epoxy specimen, dressed glass/epoxy specimens repaired using (b) 100G patches, (c) 75G25K patches, (d) 50G50K patches, (e) 25G75K patches, (f) 100K patches.

Figure 3 depicts the variation of indentation force versus indentation displacement for virgin and different repaired composite specimens subjected to multiple quasi static indentation tests. In accordance with the test results, ultimate load of virgin and different repaired specimens are shown in Figure 4. Table 2 summarizes the ultimate displacement and maximum cycles to failure for virgin and different repaired glass/epoxy specimens.

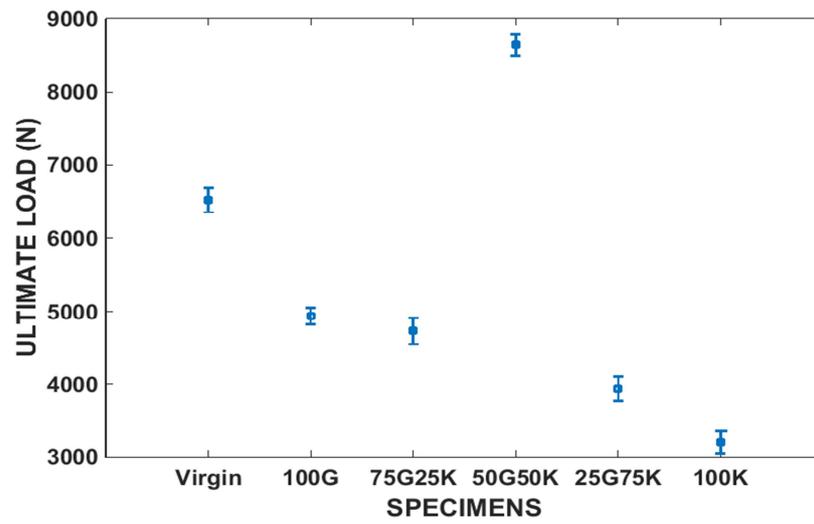
Figure 4: Ultimate load of virgin and different repaired glass/epoxy specimens.

Throughout this paper, the undamaged virgin specimens were taken as the reference for the comparison of residual mechanical properties. The performance of different repair specimens can be ranked by estimating the residual ultimate load. It can be observed that residual ultimate load after repair varies significantly with volume fraction of Kevlar and glass fibers. In particular, the 50G50K specimens show higher ultimate load than the virgin ones, provide the best indentation response. In contrast, the other hybrid and homogeneous laminates all show a decreased ultimate load compared to virgin ones, the highest loss to around 50% of the virgin specimen level was revealed by samples repaired using 100K external patches. Compared to other repaired specimens, in the case of specimens with homogeneous Kevlar patches (i.e. 100 K), the lack of adhesion to the matrix and presence of higher amount of weak hydrogen bond in the transverse direction might have considerably reduced their transverse load carrying capability [27]. These observations were explained further by using damage progression, stiffness progression, residual deflection progression and acoustic emission results from different specimens in the following sections.

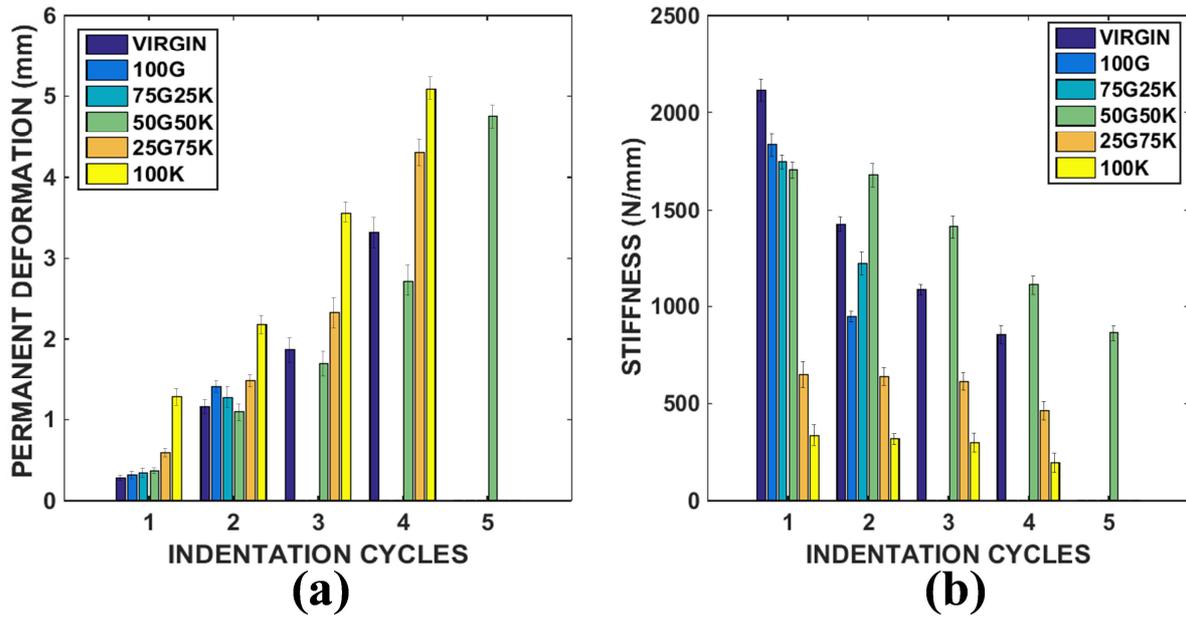
Figure 5: (a) Permanent deformation and (b) stiffness progression of virgin and different repaired glass/epoxy specimens.

Figure 5 depicts the permanent deformation and stiffness for virgin and different repair specimens at various indentation cycles. At 1st indentation cycle, for an indenter maximum displacement of 2 mm, the trend of stiffness was the inverse of the permanent deformation. From Figure 5, for an indenter maximum displacement of 2 mm (i.e., 1st indentation cycle), the virgin specimens showed the least permanent deformation and the highest stiffness. Among repaired specimens, 100G offered the highest stiffness and the minimum permanent deformation. This behavior indicates the brittle nature and lower elongation of the glass fiber. On the other hand, 100K specimens show the least stiffness and maximum permanent deformation, indicating that it withstands the applied indentation load in a ductile manner with higher deflection because of the

higher strain to failure property of the Kevlar fiber. The hybrid repair specimens exhibited a response between 100G and 100K specimens: it was clarified that increasing the volume fraction of Kevlar on the external patches reduces the stiffness of the repair specimens and causes them to withstand the transverse indentation load in a ductile manner.

After a larger number of indentation cycles (i.e., at higher indenter maximum displacement), the permanent deformation also increased. At higher indentation cycles, the virgin, homogeneous and hybrid repair specimens exhibit extremely different responses to indentation load. This evidently highlights the observation that with an increasing indenter maximum displacement, the damage mechanisms responsible for the absorption of applied mechanical energy (i.e. indentation load) are dissimilar. At higher indentation cycles, the 50G50K specimens heavily restrict the damage progression (see photographic images in Figure 6), i.e., specimen with balanced proportion of glass and Kevlar fibers outperforms other hybrid specimens, as observed in stiffness and permanent deformation plot (see Figure 5). In the 2nd indentation cycle, the indenter completely penetrated through the thickness direction of 100G and 75G25K specimens (see Figure 6). A stiffer system would increase the tensile stress on the back face for a given displacement leading to fiber dominated failure. At higher volume fraction of glass fibers in the external patches, the repaired specimens were more rigid; in practice, they exhibited ultimate failure in brittle manner with sudden and catastrophic failure mechanism (i.e., fiber breakage and splitting on the rear face). In addition, virgin specimens also exhibited higher fiber breakage and fiber/matrix debonding, whilst 50G50K specimens, being more flexible, induce damage through high deflection [27]. These observations may explain why virgin, 100G and 75G25K specimens exhibited lower stiffness and higher permanent deformation than 50G50K specimens in the 2nd indentation cycle.

On the other hand, in all indentation cycles, 100K and 25G75K specimens had the maximum permanent deformation and lower stiffness among different specimens (i.e. virgin and various repair specimens). In addition, it can be observed that by increasing the indenter maximum displacement, their permanent deformation and stiffness behavior show abruptly varying trends, indicating that the effect of repair becomes more unpredictable over repeated loading. In the 4th indentation cycle, the difference in permanent deformation and stiffness between 50G50K and virgin specimens were further higher than in 2nd and 3rd indentation cycles, because in this condition, the indenter entirely penetrated the specimen (i.e., predominant fiber breakage of the rear side glass fibers was observed). Even though 100K and 25G75K specimens had higher volume fraction of Kevlar fibers, they revealed ultimate failure at smaller ultimate deflection than 50G50K specimens: this is attributed to the fact that these repair specimens show premature delamination at the parent-patch material interface (see Figure 6). A less stiff system would reduce the stresses at the back face and instead fail with delamination dominated failure at a higher bending displacement.

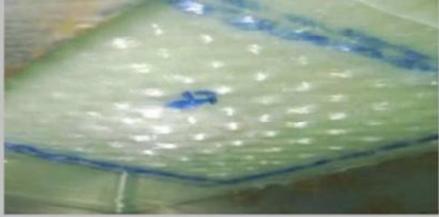
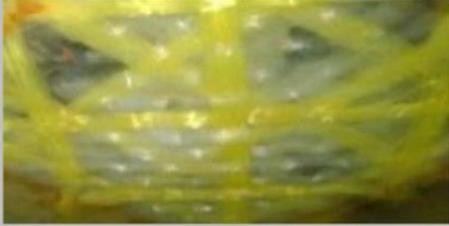
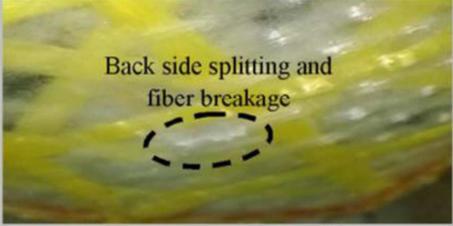
P=4070 N, D=2 mm	P= 5423 N, D=4 mm	P=6150 N, D=6 mm	P= 6520 N, D=8 mm	
100G

P=3550 N, D=2 mm		P=4940 N, D=3.08 mm		
75G25K

P=3450 N, D=2 mm		P=4730 N, D=4 mm		
50G50K

Extensive delamination
	P=448 N, D=2 mm	P= 1280 N, D=4 mm	P=2260 N, D=6 mm	P= 3200 N, D=8 mm

In the 2nd indentation cycle, for low Kevlar/glass ratio (Virgin, 100G and 75G25K), the indentation damage zone was concentrated beneath the point of application of indentation load, leading to fiber breakage (see photographic images in Figure 6). Acoustic emission localization plot also depicts that the AE events were predominantly scattered over the center region (i.e. between -20 mm to 20 mm) of the specimens (see Figure 10 (a-c)). In this indentation condition, a significant population of AE events corresponding to fiber breakage was detected. Also, in contrast to gradually increasing cumulative counts of 50G50K, 75G25K and 100K specimens, in specimens with higher amount of glass fiber (i.e. virgin, 100G and 75G25K specimens) significant increment in the cumulative counts occurs from the damage onset region itself. These results can be attributed to the presence of high amount of brittle fibers (i.e. glass fibers). Particularly, in 100G and 75K25G specimens, penetration of the indenter (i.e. ultimate failure) through the thickness, with fiber breakage and splitting on the rear or back face, can be observed (see Figure 6). Damage is generated exactly at the center of these specimens. These results were additional pieces of evidence for sudden and catastrophic brittle fracture mechanism of 100G and 75G25K specimens. Even though penetration was not observed in the 2nd indentation cycle for virgin specimens (see Figure 6), the emission of AE event associate with fiber failure was higher in virgin specimens as compared to 50G50K specimens.

In the 2nd indentation cycle (i.e. for maximum displacement of 4 mm), both 25G75K and 100K specimens showed partial bulge on the rear or tensile side (see Figure 6) as a consequence of high elongation of the Kevlar fibers of outer patches. In these specimens with high volume fraction of Kevlar, no visible fiber breakage was noticed because Kevlar has a high deflection to failure property. By reinforcing more Kevlar fibers into the external patches, the indentation damage extended to a wide area and the AE events were significant in a region between -45 mm to +45 mm (see Figure 10 (e-f)). Precisely, no localized concentration of AE events associated with fiber breakage was found at the center zone as observed for 100G and 75G25K specimens.

In this indentation condition (i.e. in the 2nd indentation cycle), 50G50K repair specimens presented an indentation response more favorable than virgin ones and other repaired specimens (see Figures 10 and 11) because the external patches have been made of equal volume fraction of glass and Kevlar fibers. The Kevlar fibers restrict penetration of indenter and prevent critical fiber breakage (see Figure 6) unlike virgin, 100G and 75G25K specimens, whereas the glass fibers restrict extensive bulge and elongation (see Figure 6) unlike 100K and 25G75K specimens.

On the other hand, in the 4th indentation cycle, it can be observed that the 25G75K and 100K specimens with higher volume fraction of Kevlar exhibited lower elongation to ultimate failure than 50G50K specimens. Critical fiber/matrix debonding (i.e., delamination) between patch and parent laminate leads to restriction of higher stresses in the farthest tensile fibers (i.e. fibers at the rear patches) to be reached and thus resulting in premature ultimate failure of 25G75K and 100K specimens compared with 50G50K specimens. Photographic images of fractured specimens also depict that the ultimate failure of 25G75K and 100K specimens did not take place by perfect local bending or by predominant breakage of fibers at the rear or tensile side patches of the specimens and no penetration of the indenter to the rear side patches were observed. However, at higher indenter displacement, fiber/matrix debonding (i.e. delamination) of the external patches from the parent laminate was observed (see Figure 6 and Figure 10 (e-f)). Normalized AE event plot also shows that maximum number of AE events corresponding to fiber/matrix debonding (i.e. delamination) damage mode significantly occurred in these specimens (see Figure 11). This evidently explains that the quasi static indentation load was not fully transferred to the tensile side patches during higher deflection, as a consequence of patch-parent laminate delamination. Moreover, from AE results, delamination (i.e. debonding) was the critical failure mode in deciding ultimate failure of 25G75K and 100K specimens repaired using high volume fraction of Kevlar fibers in the external patches as all the other hybrid specimens show ultimate failure due to breakage of fibers at the rear side. This can explain why fiber failure and fiber/matrix debonding was lower in the center zone. This explanation can be further confirmed by using photographic images of damage propagation in these specimens as shown in

Figure 6. In these specimens, fiber/matrix debonding (i.e. delamination) was the dominant damage mode deciding the load carrying capability of the specimens.

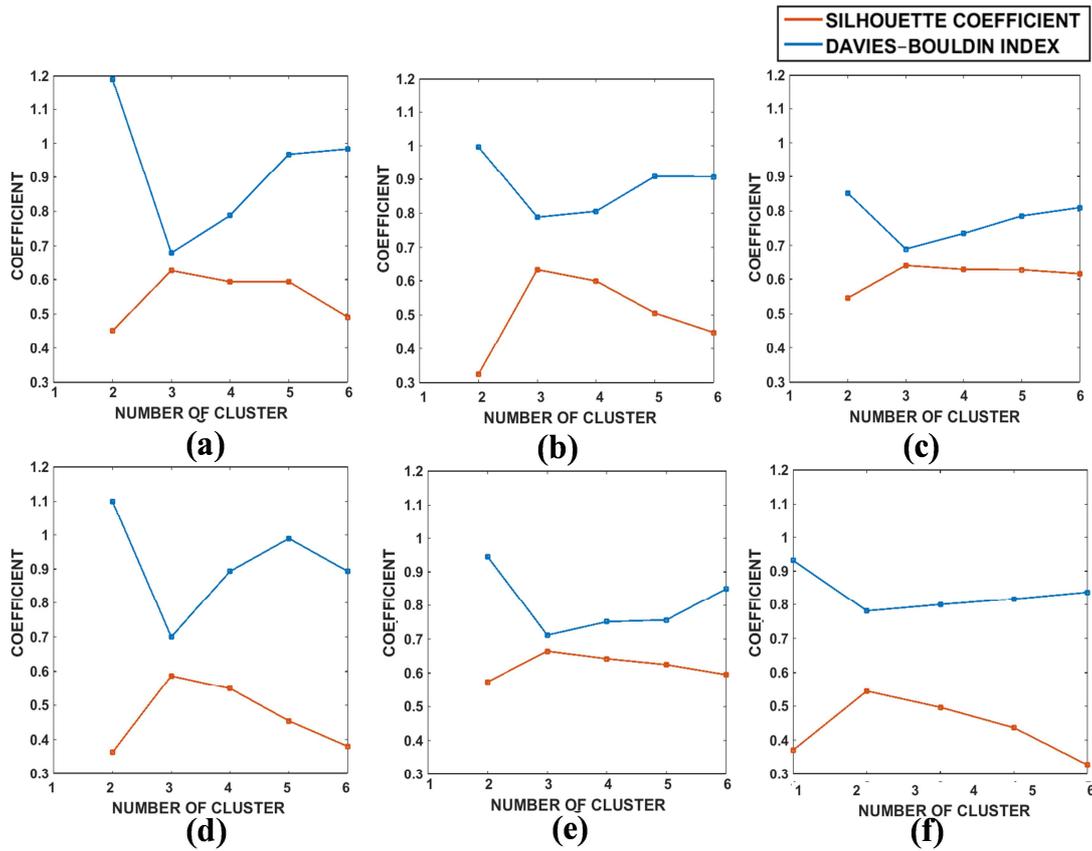
Figure 7: Davies–Bouldin index and Silhouette coefficient for (a) Virgin glass/epoxy specimen, dressed glass/epoxy specimens repaired using different patches: (b) 100G, (c) 75G25K, (d) 50G50K, (e) 25G75K, (f) 100K patches.

Unsupervised *k*-means++ analysis of recorded AE events helps in clustering the damage modes generated in the virgin and different repaired specimens, with adequate accuracy [28-29]. The idea is essentially that each damage mode produces an AE event, which is associated in turn to the amplitude of strain energy dissipated as the effect of damage in the specimens. As a result, each AE event has unique characteristics, in the sense that its RMS value, amplitude, counts, duration, frequency and other signal features are related to the failure mechanisms, such as matrix or resin cracking, fiber/matrix debonding, and fiber breakage. The significance of this fact is that different clusters for AE events, associated respectively with matrix or resin cracking, fiber/matrix debonding and fiber breakage can be obtained. AE parameters such as amplitude, duration, energy, counts, rise time, signal strength, absolute energy and RMS value were used as the descriptors to perform the analysis [28-34]. *k*-means++ analysis requires the optimum cluster number “*k*” and the high variance AE descriptors as input entries. Cluster validation parameters, such as Davies–Bouldin index and Silhouette coefficient, were used by many authors to estimate the optimal number of clusters to be opted for the statistical analysis of AE [30-31]. Both Davies–Bouldin index and Silhouette coefficient combine the principle of cohesion and separation to evaluate the optimum cluster number. Davies–Bouldin index evaluates the tightness of data points in each cluster from the proportion of distribution of data points within a particular cluster and the Euclidean distance between the centroid of two nearby clusters. Therefore, the optimal number of clusters should present the lowest value of Davies–Bouldin index, which represents the compactness of data points in a cluster, allows no data points in a cluster similar to other and not excessively short Euclidean distance between the centroids of two clusters. Here, the most favorable value is likely to be less than one [30]. In contrast, Silhouette coefficient measures average Euclidean distance between the data points within a cluster and between two clusters to evaluate how dissimilar each cluster is from any other cluster. Silhouette coefficient (SC) determines how well-separated or dissimilar each cluster is from any other cluster by using average distance between the data points within and between two clusters. Here, the best clusters number should present the highest value of Silhouette coefficient, representing that a data point is compatible to a particular cluster, and incompatible to any other cluster. In this case, the optimal value is expected to be in the range 0.6 to 0.7 according to [30]. Optimum number of clusters (i.e. damage modes) estimated by Davies–Bouldin index and Silhouette coefficient (Table 3) from the recorded acoustic emission events is shown on Figure 7. It can be observed that cluster number *k*=3 were most favorable for clustering the AE data of all the glass/epoxy specimens. The cluster validity evaluations for virgin and different repaired specimens are summarized in Table 3.

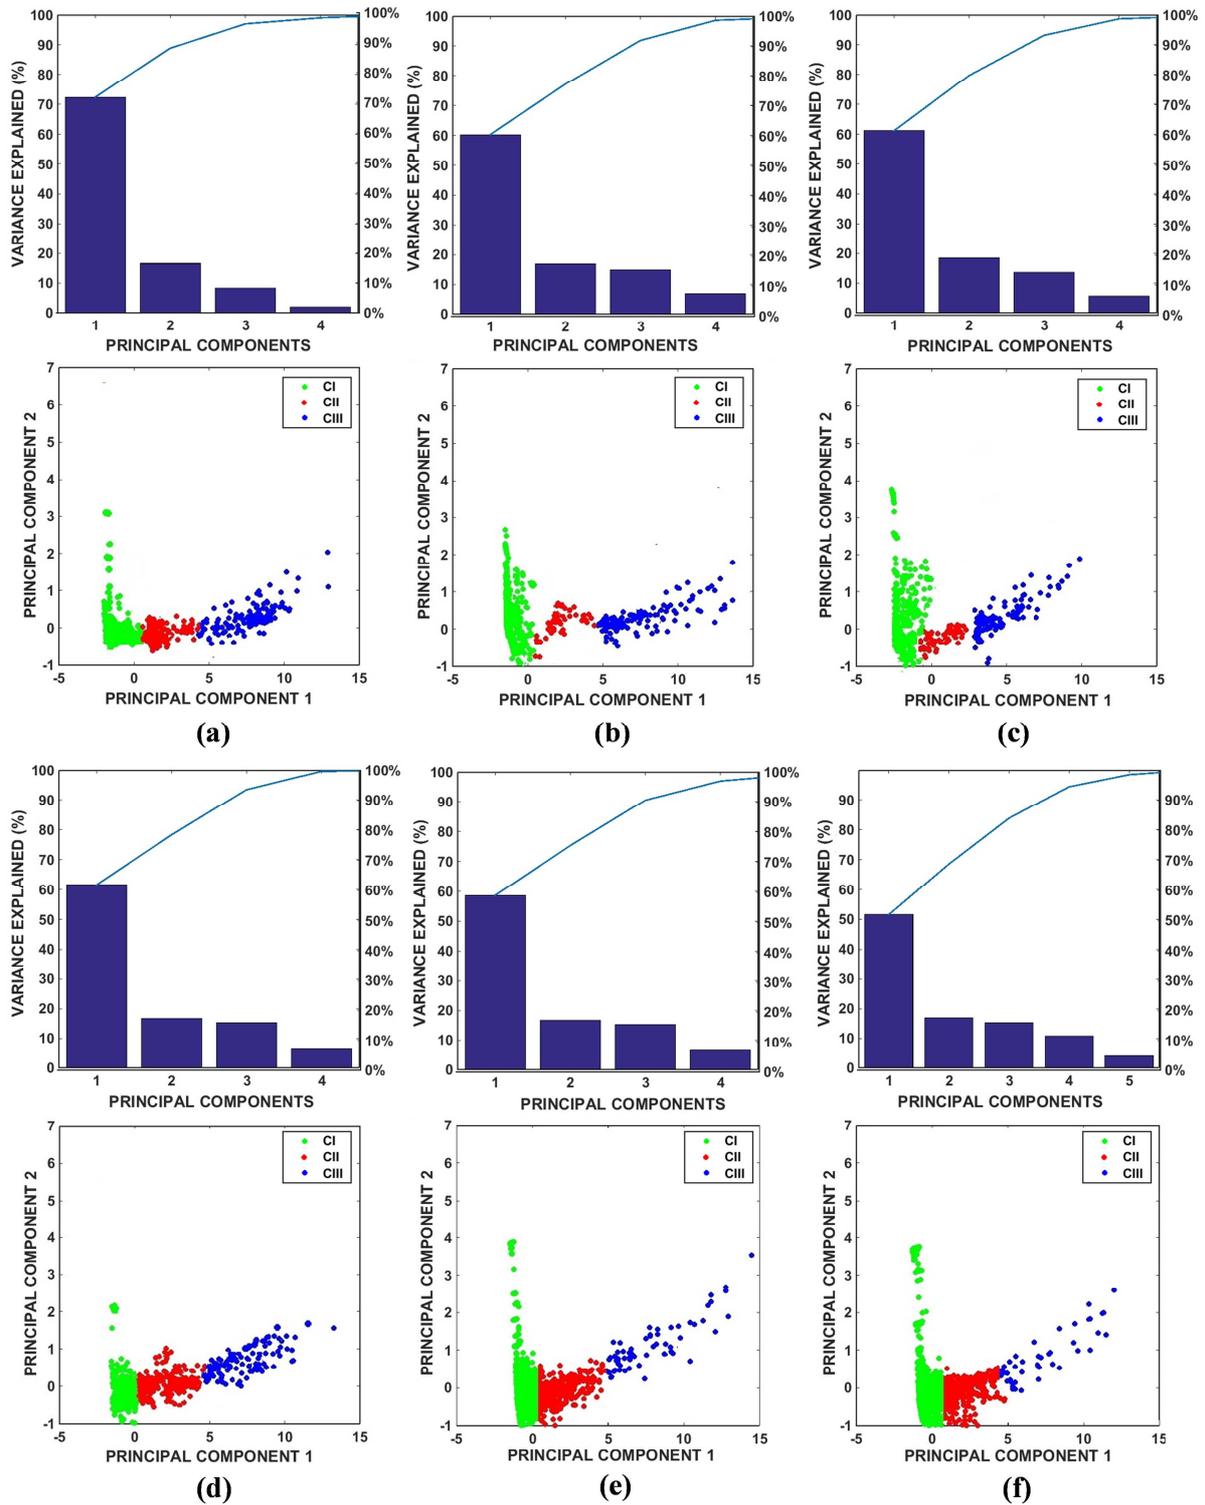
Figure 8: The variance of principal components and PCA visualization of *k*-means++ clustering for (a) Virgin glass/epoxy specimen, dressed glass/epoxy specimens repaired using (b) 100G patches, (c) 75G25K patches, (d) 50G50K patches, (e) 25G75K patches, (f) 100K patches.

variance and cumulative sum of the variance of each principal component is illustrated in Figure 8. For the whole of glass/epoxy specimens, it was noticed that the cumulative sum of variance of the descriptors amplitude and duration (i.e., first two principal components) provide above 75% of the total variance of the data sets. Since the AE parameters such as amplitude and duration of AE waveform were sufficient to evaluate the failure mechanisms that govern the damage progression of the glass/epoxy composite specimens, the data interpretation is restricted to the first two principal components in the following sections.

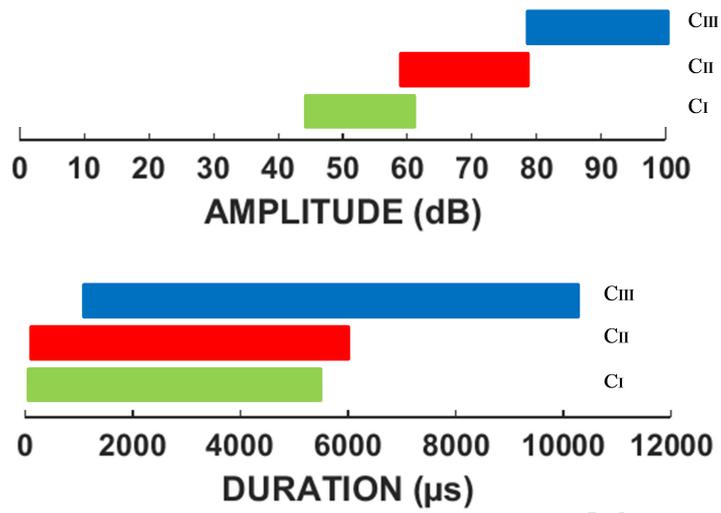
Figure 9: The summary of the failure mode discrimination using amplitude and duration ranges.

Amplitude and duration ranges associated with clusters C_I , C_{II} , and C_{III} are summed up in Figure 9. These distinct ranges can perhaps be related with different failure mechanisms. Generally, it was frequently reported in most of the literature that the AE events with least amplitude and duration correspond to matrix or resin cracking, those with highest amplitude and duration correspond to fiber failure, and those with mid-amplitude and duration ranges relate to delamination or fiber/matrix debonding damage modes [33-34]. Therefore, the pertinent amplitude and duration ranges were: amplitude range 45-61 dB and duration range 0-5611 μ s allied to the matrix or resin cracking, amplitude range 58-78 dB and duration range 0-5940 μ s allied to the fiber/matrix debonding, and amplitude range 78-100 dB and duration range 983-10420 μ s allied to the fiber breakage.

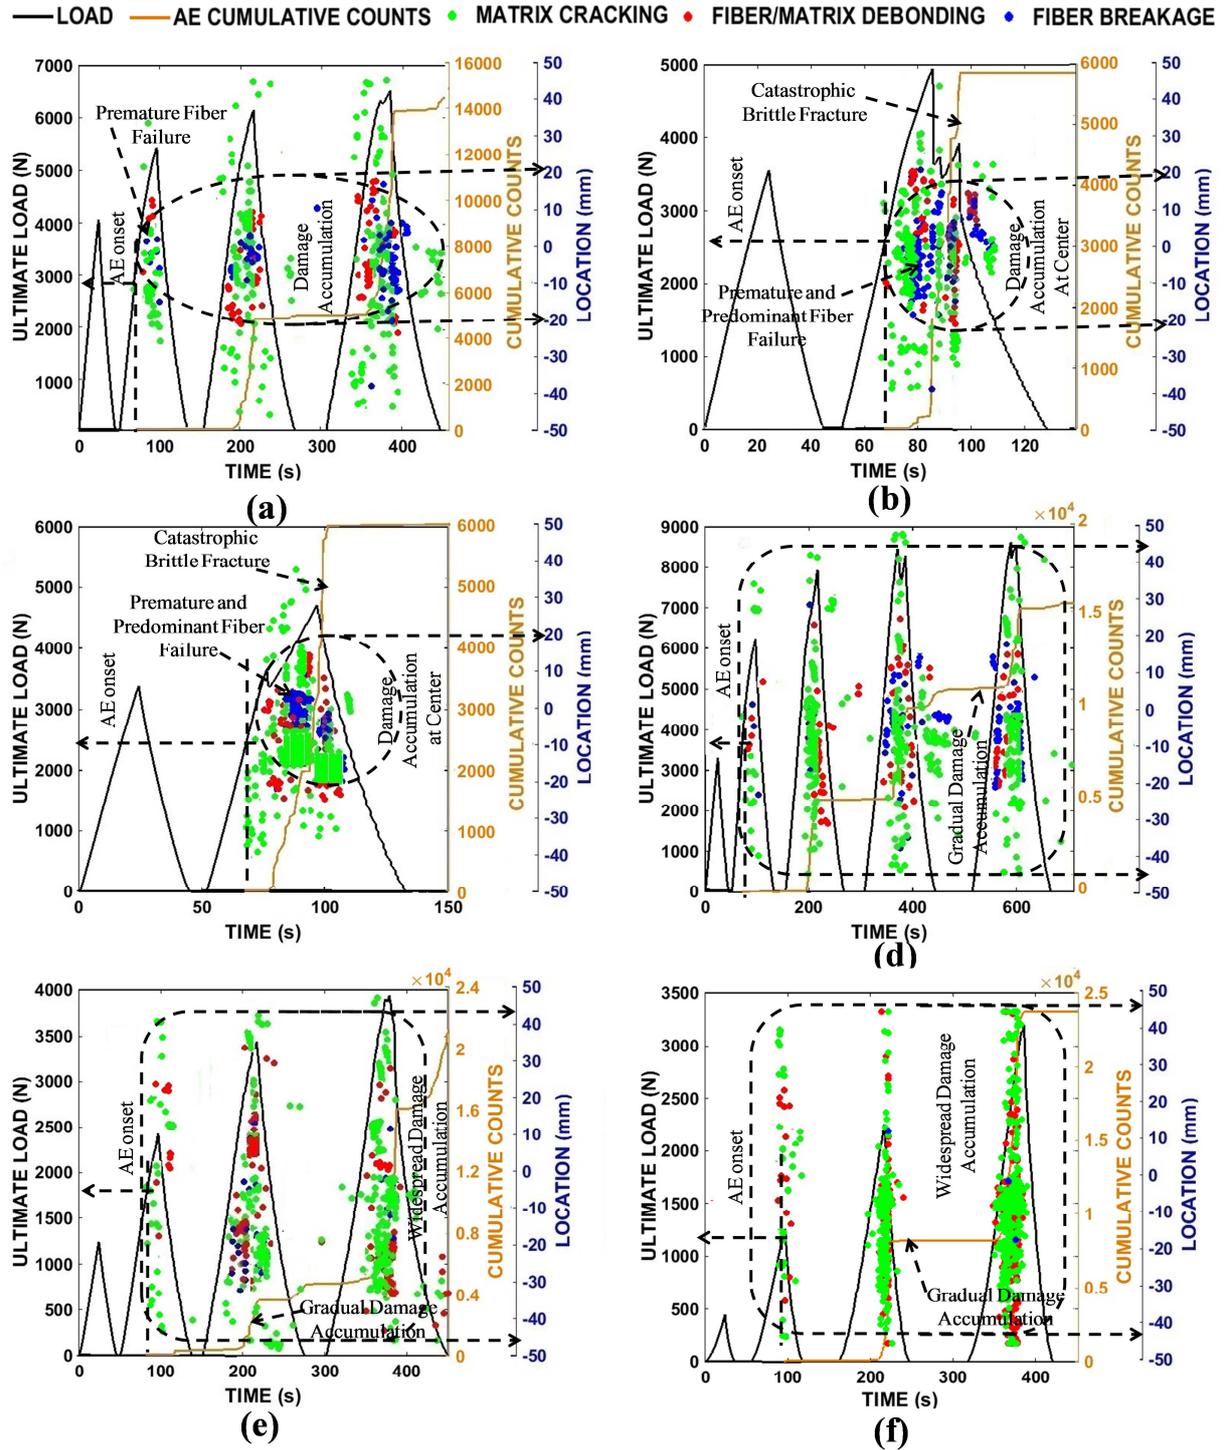
Figure 10: Indentation load, AE cumulative counts and AE event location versus time for (a) Virgin glass/epoxy specimen; dressed glass/epoxy specimens repaired using (b) 100G patches, (c) 75G25K patches, (d) 50G50K patches, (e) 25G75K patches, (f) 100K patches.

The main step in investigating the multiple indentation behavior of different repaired specimens is to characterize the nature and extent of the damage induced at each indentation cycle. The damage modes corresponding to the clusters C_I , C_{II} , and C_{III} were identified and the correlations between failure location of various damage modes, indentation load, and AE cumulative counts are depicted in Figure 10. The indentation loads required for occurrence of various AE events distributed in these clusters were found to illustrate the chronology of different damage modes with increase of load. In particular, this plot indicates the kinetics of the various damage modes individually in real-time. It can be observed that each consecutive incremental loading step generated more AE events because the indenter maximum displacement increased and consequently damage accumulated. It was also clear that the rate of AE events emitted was maximized when the indenter maximum displacement had almost reached the ultimate value for each indentation cycle. After the peak displacement, the rate of AE event acquisition decreased significantly until up to the next reloading indentation cycle that goes beyond the preceding cyclic ultimate load, as observed in Figure 10.

In general, the failure mode progression mainly depends on the indentation parameters of the test and the material parameters of the specimens. It can be observed in Figure 10 that the nature of damage progressions for virgin, hybrid and homogeneous specimens were entirely different. Figure 11 illustrates the normalized number of overall AE events versus cluster number for virgin and for different repaired glass/epoxy specimens under indentation loading. The similarities of the C_I , C_{II} and C_{III} AE events for different specimens can be better visualized

using the normalized number of overall AE events as a function of different clusters, as some AE events in Figure 10 were overlapped. Fiber/matrix debonding and fiber breakage were the critical failure modes in determining the ultimate load carrying capability of the specimens considered in this study, because the matrix cracking failure mode was recorded almost equal in all the specimens. The dominant damage mechanism leading to ultimate failure with the glass fiber reinforced specimens is fiber breakage, whereas for Kevlar it is fiber/matrix debonding. This behavior evidently highlights that the failure mechanisms responsible for the absorption of applied energy (i.e. indentation load) were different for different specimens.

Furthermore, in the 3rd indentation cycle (i.e. for maximum displacement of 6 mm), the virgin specimens have a higher amount of fiber breakage AE events than the 50G50K ones (see Figure 10 (a) and (d)). In the 4th indentation cycle, the difference between 50G50K and virgin specimens was considerably higher than in the earlier indentation cycles. For virgin specimens, higher fiber breakage and penetration of the indenter in the 4th indentation cycle were the most dominant factors governing the premature ultimate failure of the specimens as compared to 50G50K repair specimens (see Figure 10 (a) and (d)).

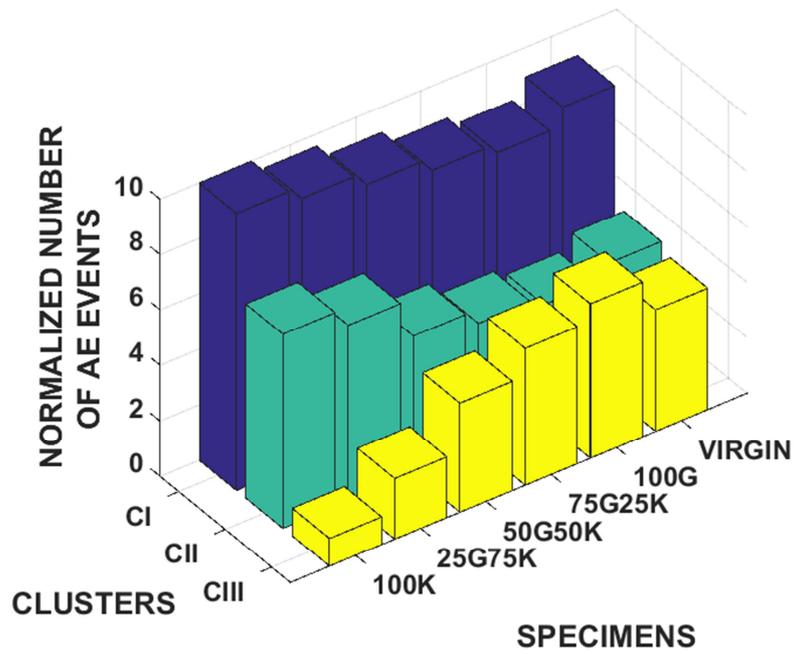
Figure 11: Normalized number of AE events (%) versus clusters for virgin and different repaired glass/epoxy specimens.
