Anticipated and actual performance of composite girder with pre-stressed concrete beam and RCC top flange

K. Gurunaathan*1, S. Christian Johnson^{2a} and G.S. Thirugnanam^{3b}

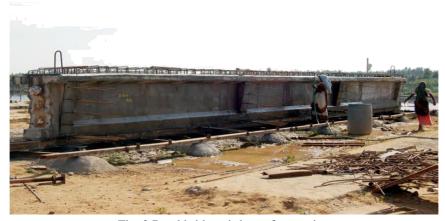
Fig. 1 Road bridge girder - skeleton reinforcement and sheathing pipes

- All cables are of 12 T 13 pre-stressing system with 66mm ID sheathing and are uncoated stress relieved low relaxation seven ply strands conforming to IS: 14268 1995. The reinforcements were locally adjusted wherever they interfered with sheathing.

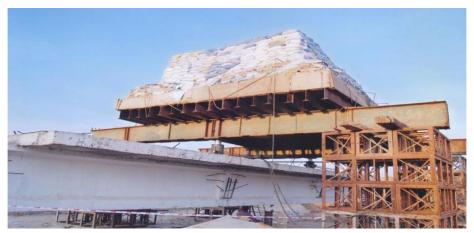
Fig. 3 Load test set up

The load test has been carried out on the composite girder consisting of one PSC girder with 2.5 m wide RCC slab cast atop the girder simulating the field conditions. For

the load test, two point loads of equal magnitude are applied with one each at the middle third points (centre of the intermediate diaphragms) of the span. The test loads applied are of such a magnitude that the resulting bending moment at the mid span does not exceed the maximum bending moment caused by 1.25 times design superimposed loads.

The load test is carried out in stages of up to 1.25 times the design super imposed load. The total Kent ledge load arranged was 1530 kN. The total maximum test load applied in this test was 940 kN and the corresponding theoretical deflection was 12.26 mm. The load was applied on to the test girder as two loads of same magnitude at two points, one each at the location of the intermediate

diaphragms by means of 2 numbers of hydraulic jacks of 1000 kN capacity each, operated in tandem. The test load was increased in stages from zero to the maximum test load of 940 kN (total) and this maximum load was maintained for 24 hours and thereafter the load was reduced to zero in stages. At each of the loading and unloading stages, the deflection of the girder at mid span was recorded using dial gauge.
