Innovative methods for improving performance of transmission line tower foundations against corrosion in marine environment

In the study a few innovative methods for rehabilitation of transmission line tower foundations based on laboratory investigations have been presented. Protective methods like O-ring provision in the stub angle concrete interface, various levels of protective methods including nano penetrant coatings to combat the crevice corrosion, has been suggested for field applications in marine environment.

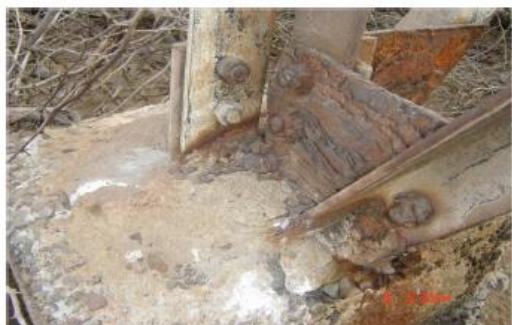
As the stub angle interface is exposed to the atmosphere which has a higher concentration of oxygen with respect to the stub angle below the interface, there is a possibility of differential aeration – type of corrosion to occur like a ring of rust around the stub angle interface. The difference in moisture level and salt content at the interfacial zone prevailing in the marine zone aggravates the corrosion process. Though such a type corrosion is quite prevalent in the interfacial zone in all the towers, the intensity is higher in the coastal zones. Ennore is one of the marine area located in the North Chennai area where lot of refineries and plastic industries are in existence. For facilitating power supply, this area is also having three major thermal power plants where around 2000 MW power is generated. For connecting the load centers with the thermal power stations through sub stations lot of transmission towers are in use in this area. But due to marine environmental exposures many towers are getting corroded and repair works are taken up on regular basis every year like painting, removal of rust, replacing the corroded angle with new angle, providing new concrete etc., Fig.2 shows a ring of rust formed at the interfacial zone of a transmission tower present in Ennore, Tamil Nadu, India.

Fig 2. Ring of Rust at Interface of transmission tower stub at ground level

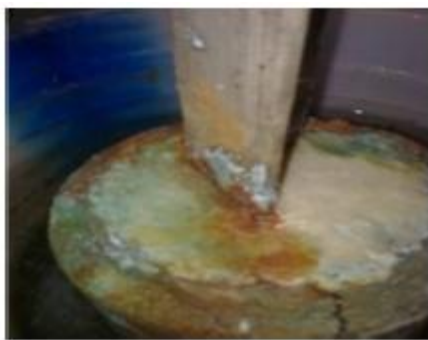
Deep grouting out of Demech chemical for forming O-ring in the stub angle and concrete interface shows no symptom of rust staining till 400 hrs of accelerated corrosion. At 500 hrs few rust spots has been noticed. The effect of O-ring against crevice corrosion is very good for nano penetrant coated specimen. Fig.3 shows performance of O-ring out of deep pour grouts after 500 hrs of accelerated corrosion.

a. O-ring and Cement slurry coated surface

Fig.3. Performance O-rings after 500 hrs of accelerated corrosion

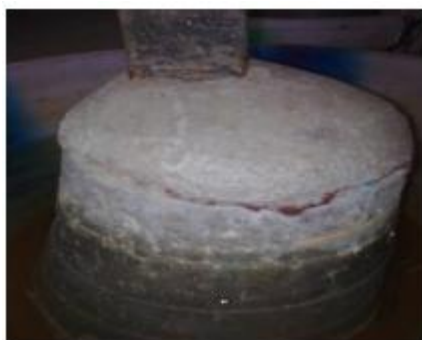
b. O-ring and Nano Zycosil coated surface
