A study on transmission line tower foundation in marine environment

Experimental evaluations about the performance of transmission line tower foundation concrete with different mineral admixtures/chemical admixtures and coatings have been done by conducting tests such as rapid chloride penetration test, acid test, chloride immersion test, etc., Protective measures like woring provision, coatings with chemicals, have also been suggested based on the experimental studies to reduce crevice corrosion. Actual stub removed from the field has been used to examine the depth and pattern of cracks.

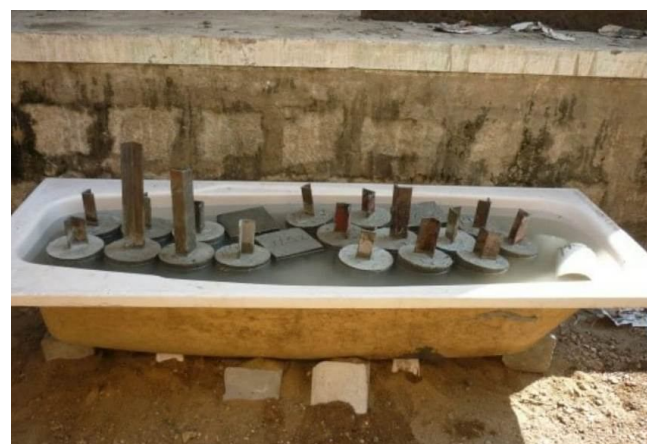
Fig. 1 — Curing of Testing Specimens

Laboratory specimens in different grades of concrete, with admixtures and steel angle surface coatings^{7,8,9} were cast to observe the corrosion phenomena under accelerated test condition. For comparison purpose, uncoated angle specimens were also tested under similar accelerated test condition to determine the efficiency of the surface coating. The curing of test specimens is shown in Fig. 1.

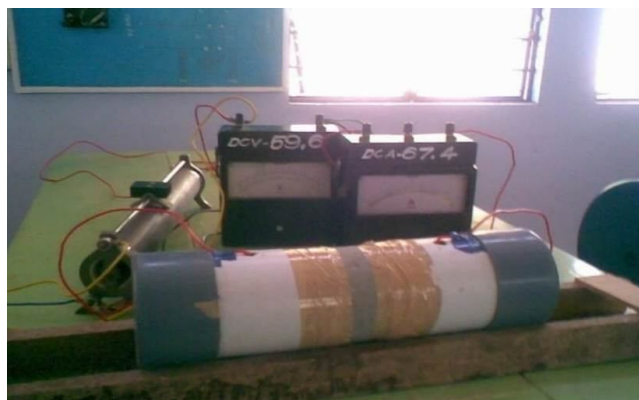
Fig. 2 — View of Rapid chloride penetration test set up

One of the principal sources of corrosion problem is the ingress of chloride ions into porous concrete. It is often necessary to ascertain the impermeability of concrete to chloride ions as a quality control measure^{10,11}. Since measurement of chloride diffusion co-efficient requires a long time for establishment of steady state conditions, a direct current (DC) potential is applied to accelerate migration of ions. In this present study, the Rapid chloride penetration test (RCPT) was performed as per ASTM C 1202. The test method consists of monitoring the amount of electrical current passed through 51 mm thick slices of 102 mm nominal diameter of cylindrical specimens for duration of six hours. The RCPT test set up is shown in Fig. 2.

The RCPT apparatus consists of two reservoirs. The specimen was fixed between two reservoirs using an epoxy bonding agent to make the test set up leak proof. One reservoir (connected to the positive terminal of the DC source) was filled with 0.3 N

sodium hydroxide solution and the other reservoir (connected to the negative terminal of the DC source) with three percent sodium chloride solution. A DC of 60 V was applied across the specimen using two stainless steel electrodes and the current across the specimen was recorded at 30 minute interval for duration of six hours.

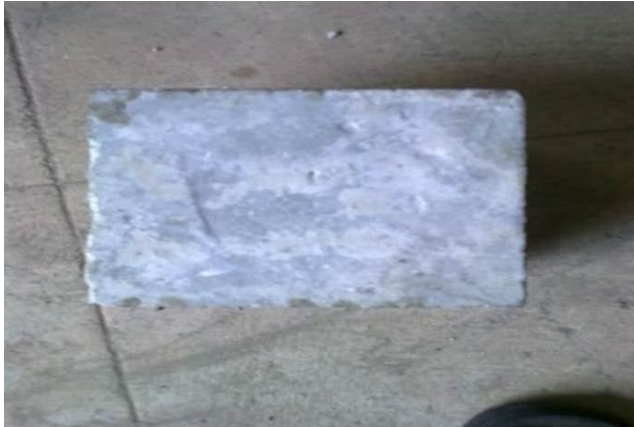
Fig. 6 — Specimen coated without zycosil

Nano coating material called Zycosil was applied on a cube specimen¹⁷ and after setting, water was sprayed upon the surface. Water particles stood as on

the top of lotus leaves. The specimen was scraped and again water was sprayed, till water was absorbed.

Fig. 6 & Fig. 7 show the specimen coated without and with zycosil respectively.

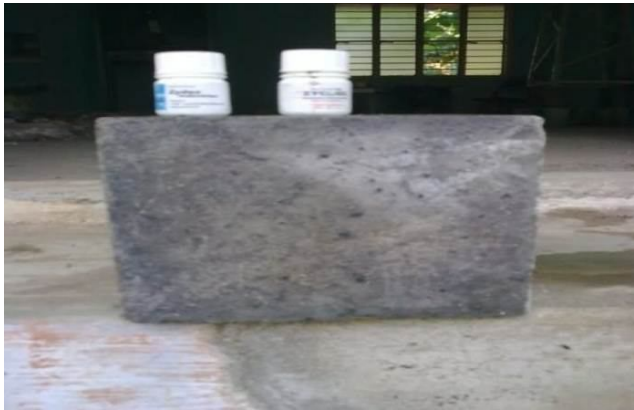
Fig. 7 — Specimen coated with zycosil

Specimens coated with nano coating [zycosil], show a superior form of water repellant. Even after scraping for 1 mm depth, the water particles stood similarly, thus showing a higher order of durability for coating on concrete surfaces.

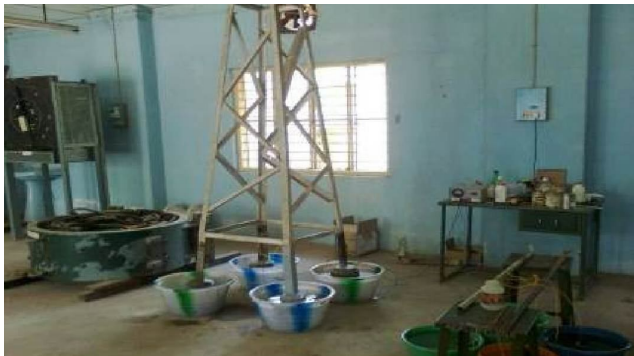
Fig. 8 – Model tower

A model transmission line tower was fabricated and used for experimentation. Concrete has been cast around four legs as that of a coping. In order to eliminate crevice corrosion in the interface of the concrete and stub angle deep grout material of Demech chemical was poured and observation was made under accelerated corrosion^{7,8}.

Fig. 8 shows the model tower fabricated and tested in the laboratory.

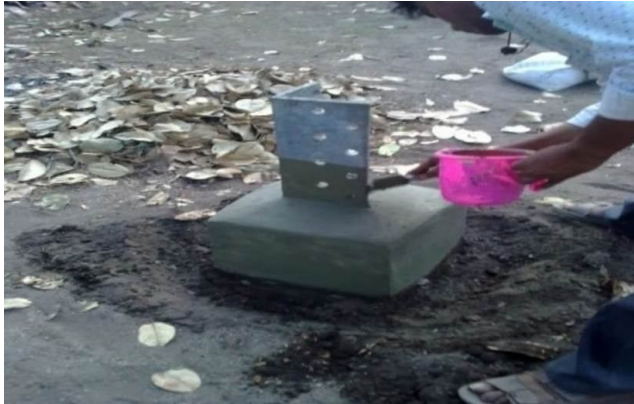
Fig. 9 — Flexibond coating on galvanized stub angle

In order to study the durability of transmission line tower foundations embedded with Galvanized stubs experimentally, four numbers of stub concrete were formed on the floor. After 28 days of curing, outer coating with flexibond ACSR was applied on one stub and in other leg demech chemical was coated. The remaining two legs were left uncoated to observe the difference. All the stubs were induced corrosion by spraying salt water, which had 3.5 % NaCl. The Half cell readings during 15 days of alternate wetting and drying cycle, were taken to ensure the corrosion formation. The flexibond coating on galvanized stub angle is shown in Fig. 9 even as the half cell potentiometer readings are given in Table 9.

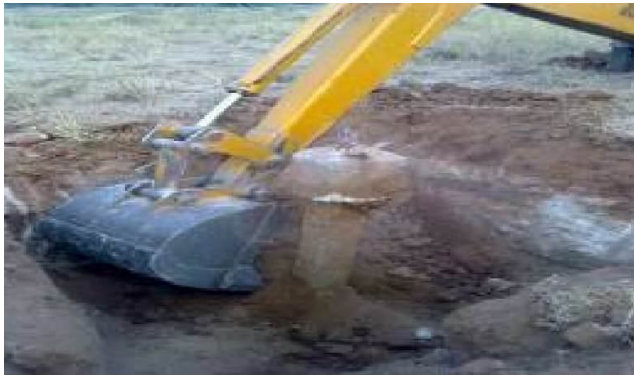
Fig. 10 — Removal of stub in Coimbatore (Inland)

As a part of the study, two transmission line tower stubs, one in Coimbatore (Fig. 10) and other in Chennai (Fig. 11) were removed by excavation. The stubs of these towers were erected nearly 30 to 35 years ago, and the super structures had been already

i) Coimbatore, Othakalmandapam – Palladam line: 110 KV line – Tower No. 4, Length of stub: 1.5 m, Size of stub: Top: 25x25 cm, Bottom: 15x15cm.

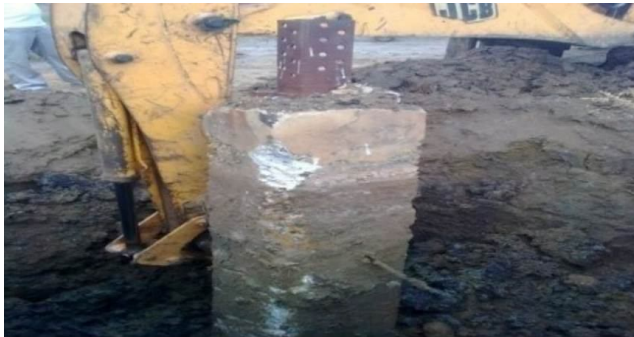
Fig. 11 — Removal of stub in Chennai (Coastal)

ii) Chennai, Ennore Thermal Power Station to Manali - 110 KV line. – Tower No.28, Length of stub: 2.2 m, Size: 45x 45 cm.

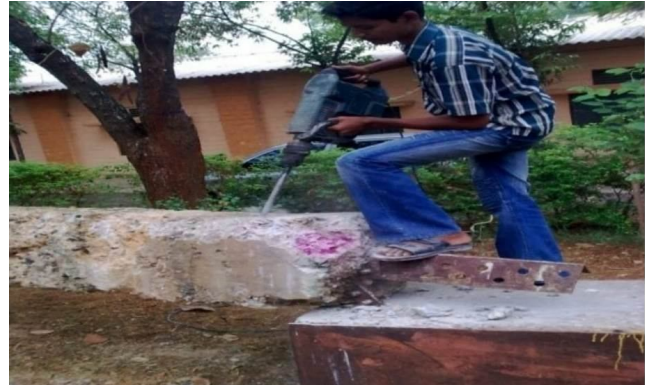
Fig. 12 — Stub excavated in Coimbatore (Inland)

Excavated tower was broken in the lab to study the crack depth and pattern and extent of deterioration of concrete. Table 10 shows the crack depth and width of stubs.

The stubs excavated in Coimbatore and Chennai were brought to testing laboratory and they are shown in Fig. 12 and Fig. 13 respectively.

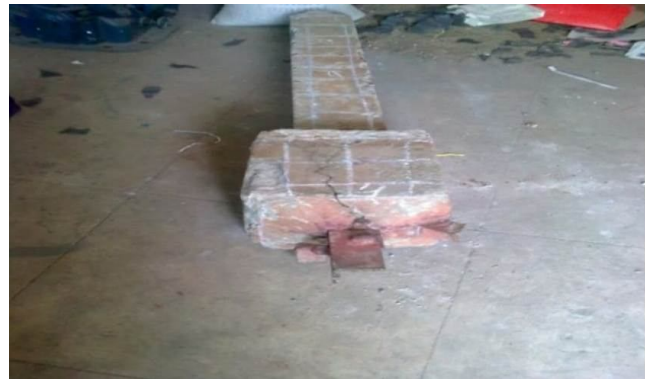
Fig. 13 — Stub excavated in Chennai (Marine environment)
